Presented by: TIMOTHY D. STARK & JIALE LIN University of Illinois at Urbana-Champaign <u>tstark@Illinois.edu</u>

Presented to: Queensland Tailings Group Brisbane, Australis June 9, 2022

Fundao Failure Outline

2015 Fundao Tailings Dam Failure

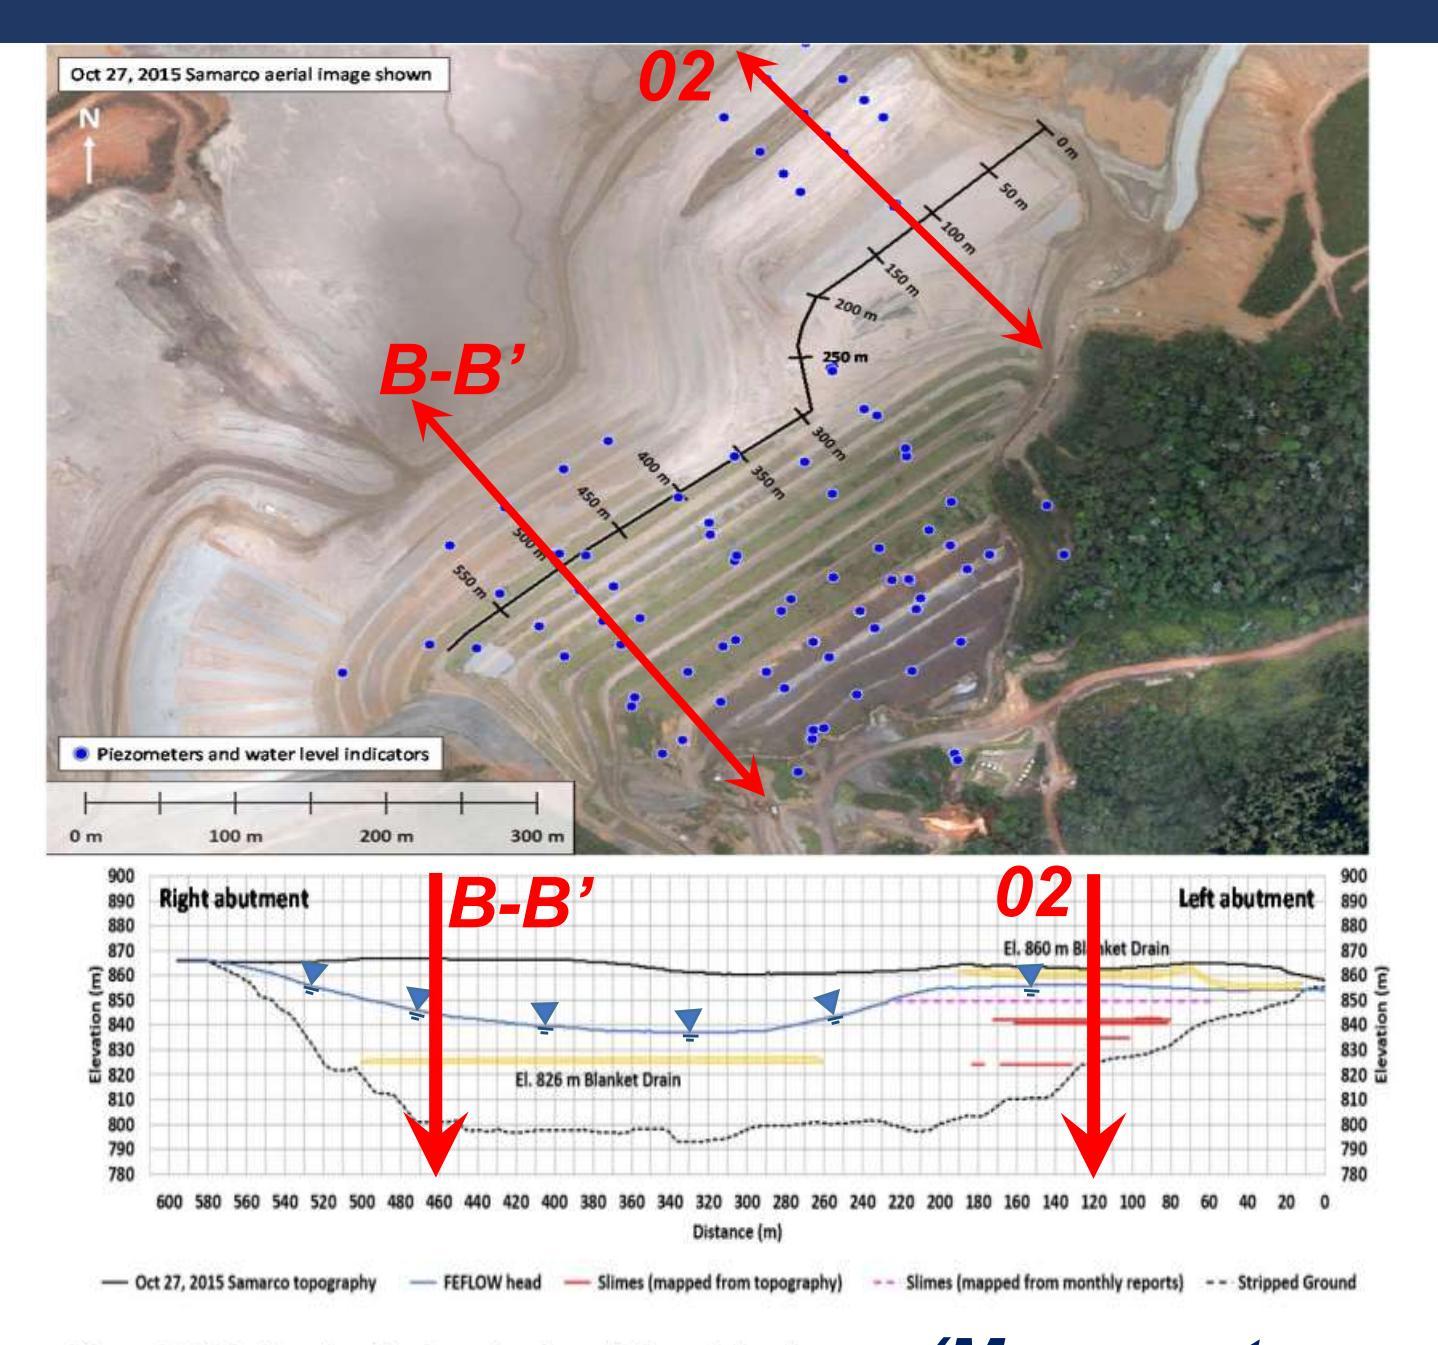
Figure B6-12 Longitudinal section from left to right abutment (Morgenstern et al., 2016)

Piezometric Levels

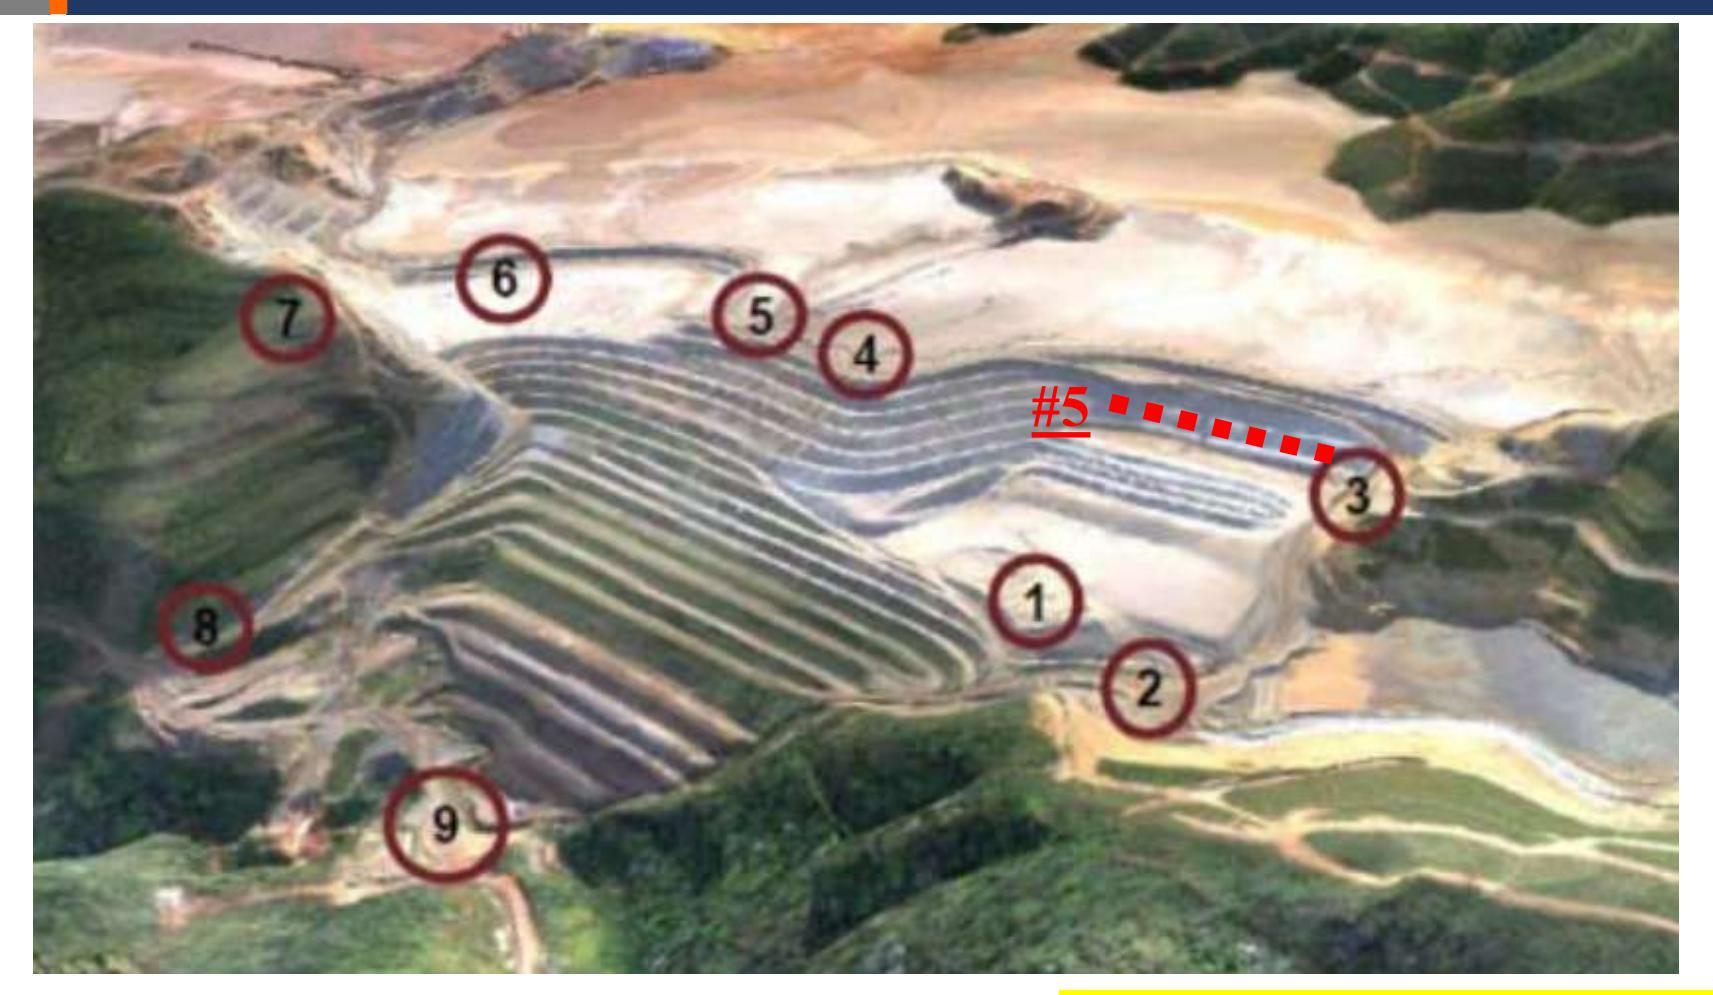
Witness Location and Description

#9: Avalanche of mud-like tailings cascaded down. The starter dam had no movement

#5: Crack open up along crest ofleft abutment setback andpropagating in both direction

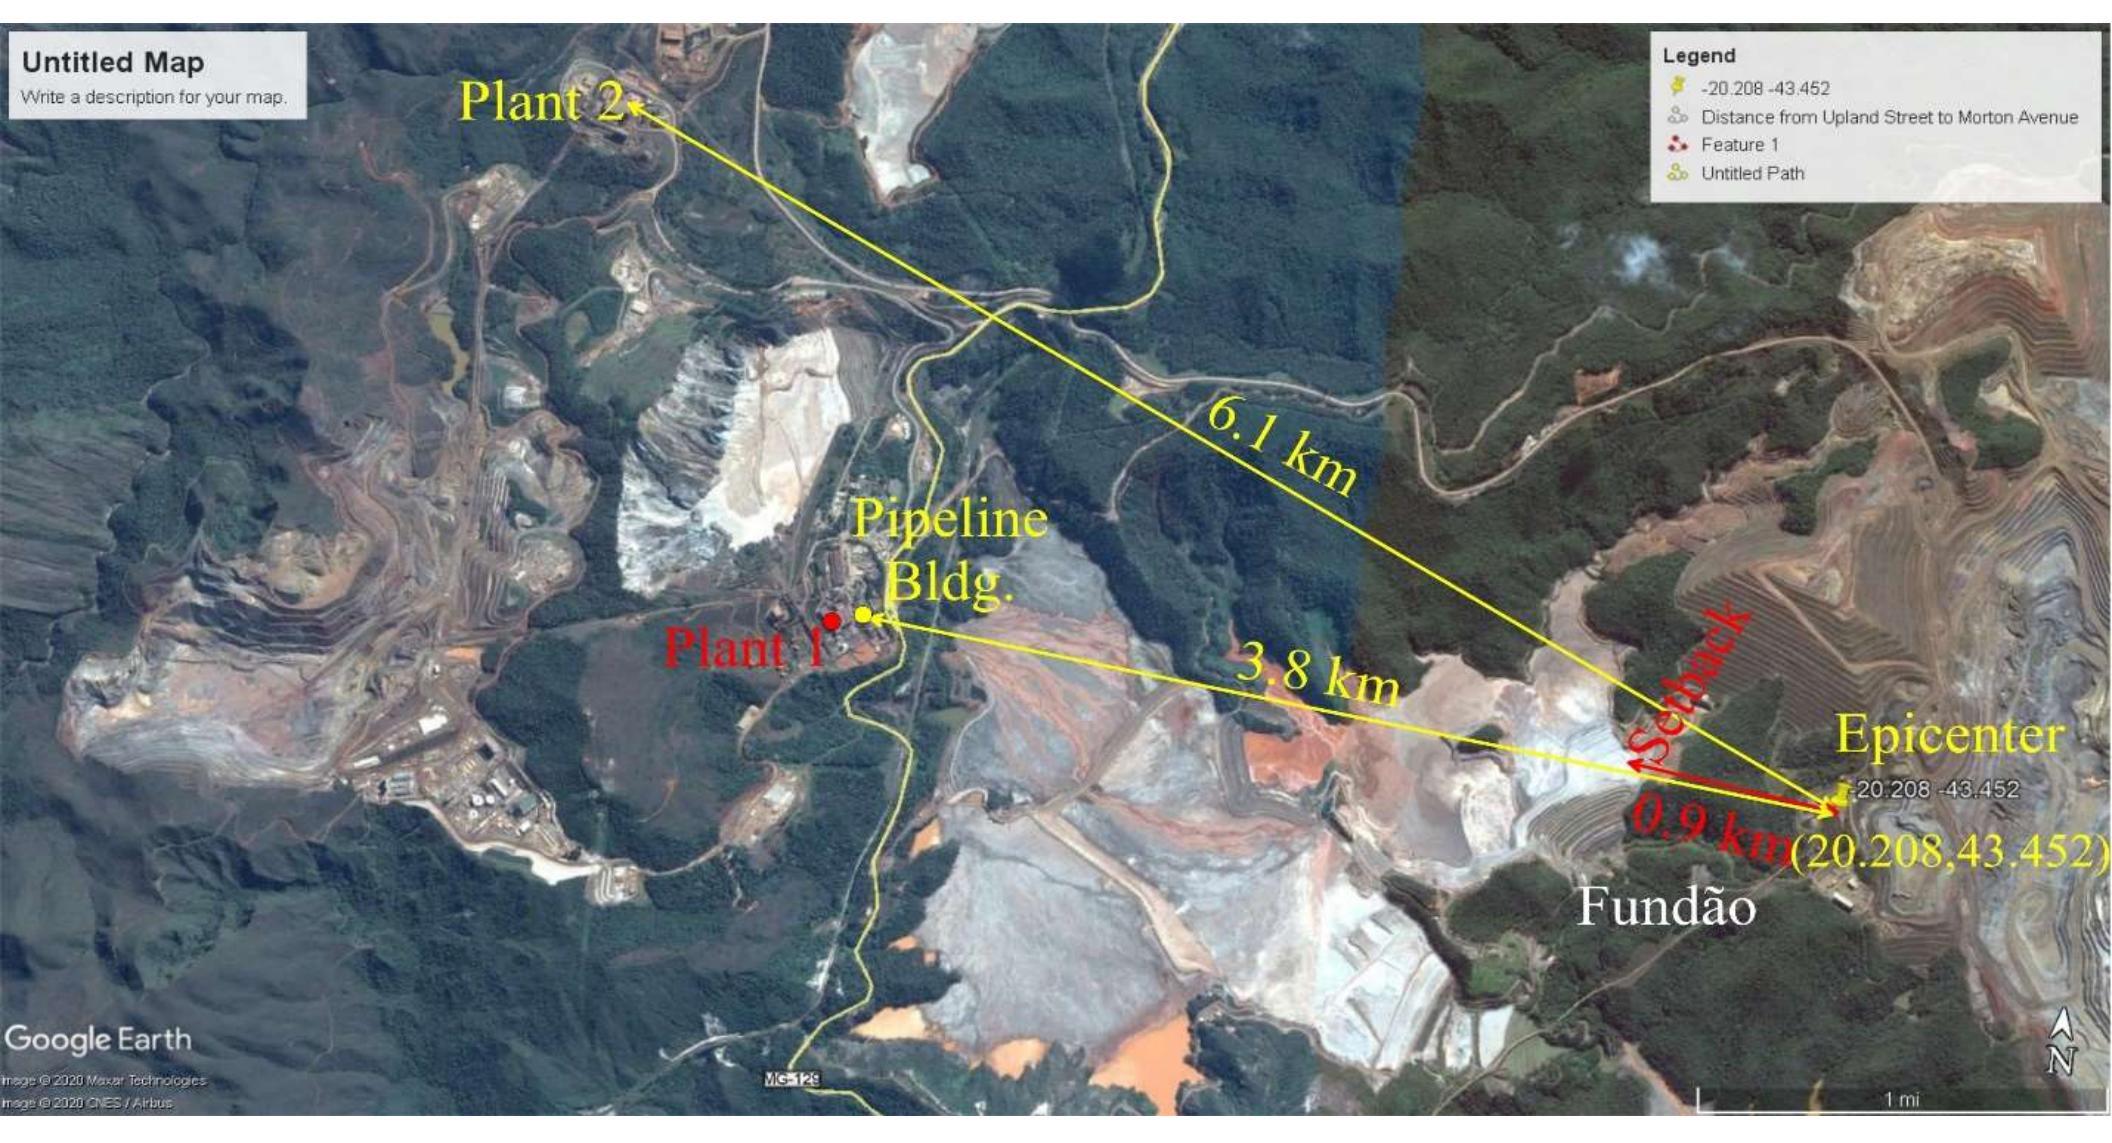
Ciardelli and Assumpacao (2019) Epicenter coordinates

Eyewitness Accounts of 11/5/15 Earthquakes:

- Shaking strong enough to cause computer to fall from tabletop and minor structural cracking (Morgenstern et al., 2016)
- Viviane Rezende -2^{nd} eqk shook truck on dam
- Daviely Silva Desk shaking & broken glass
- **MMI** ~ 5 to 6
- $M \sim 4 \text{ to } 5$

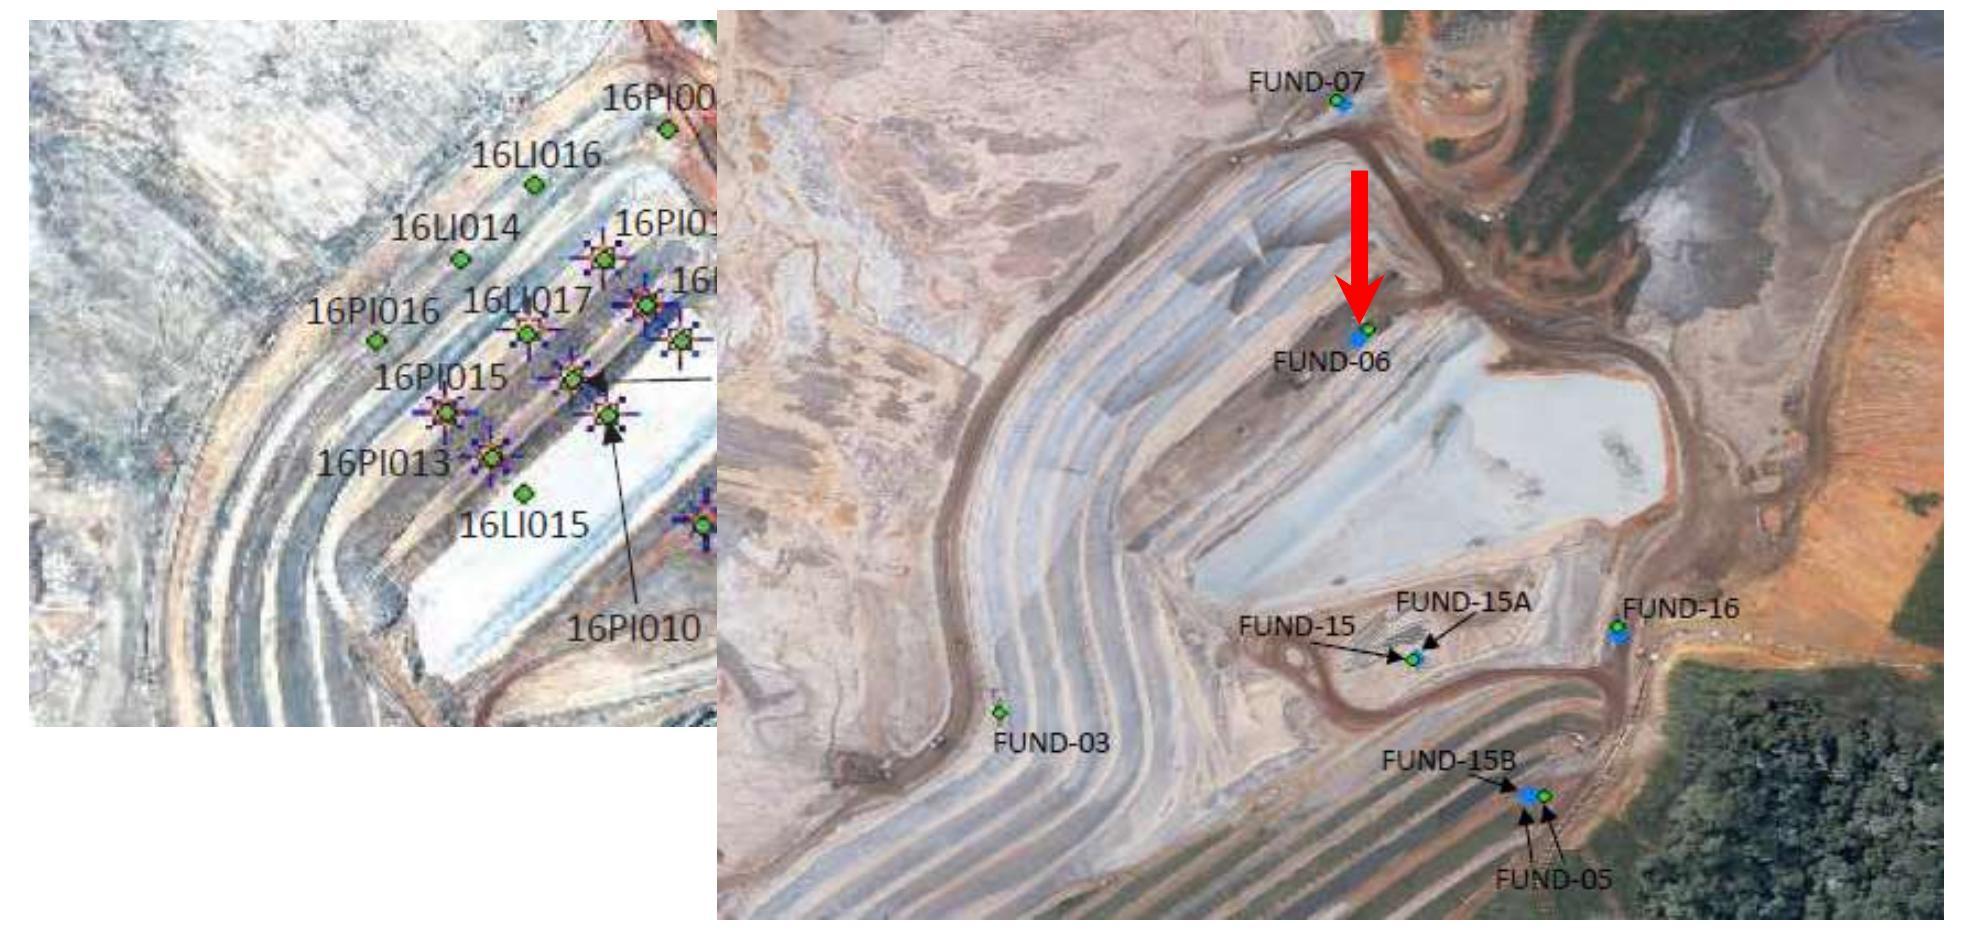
Pre-Failure CPT Data-FUND 06-CPT

Tailings Sand_{Slope}: Depth = 4.25 m

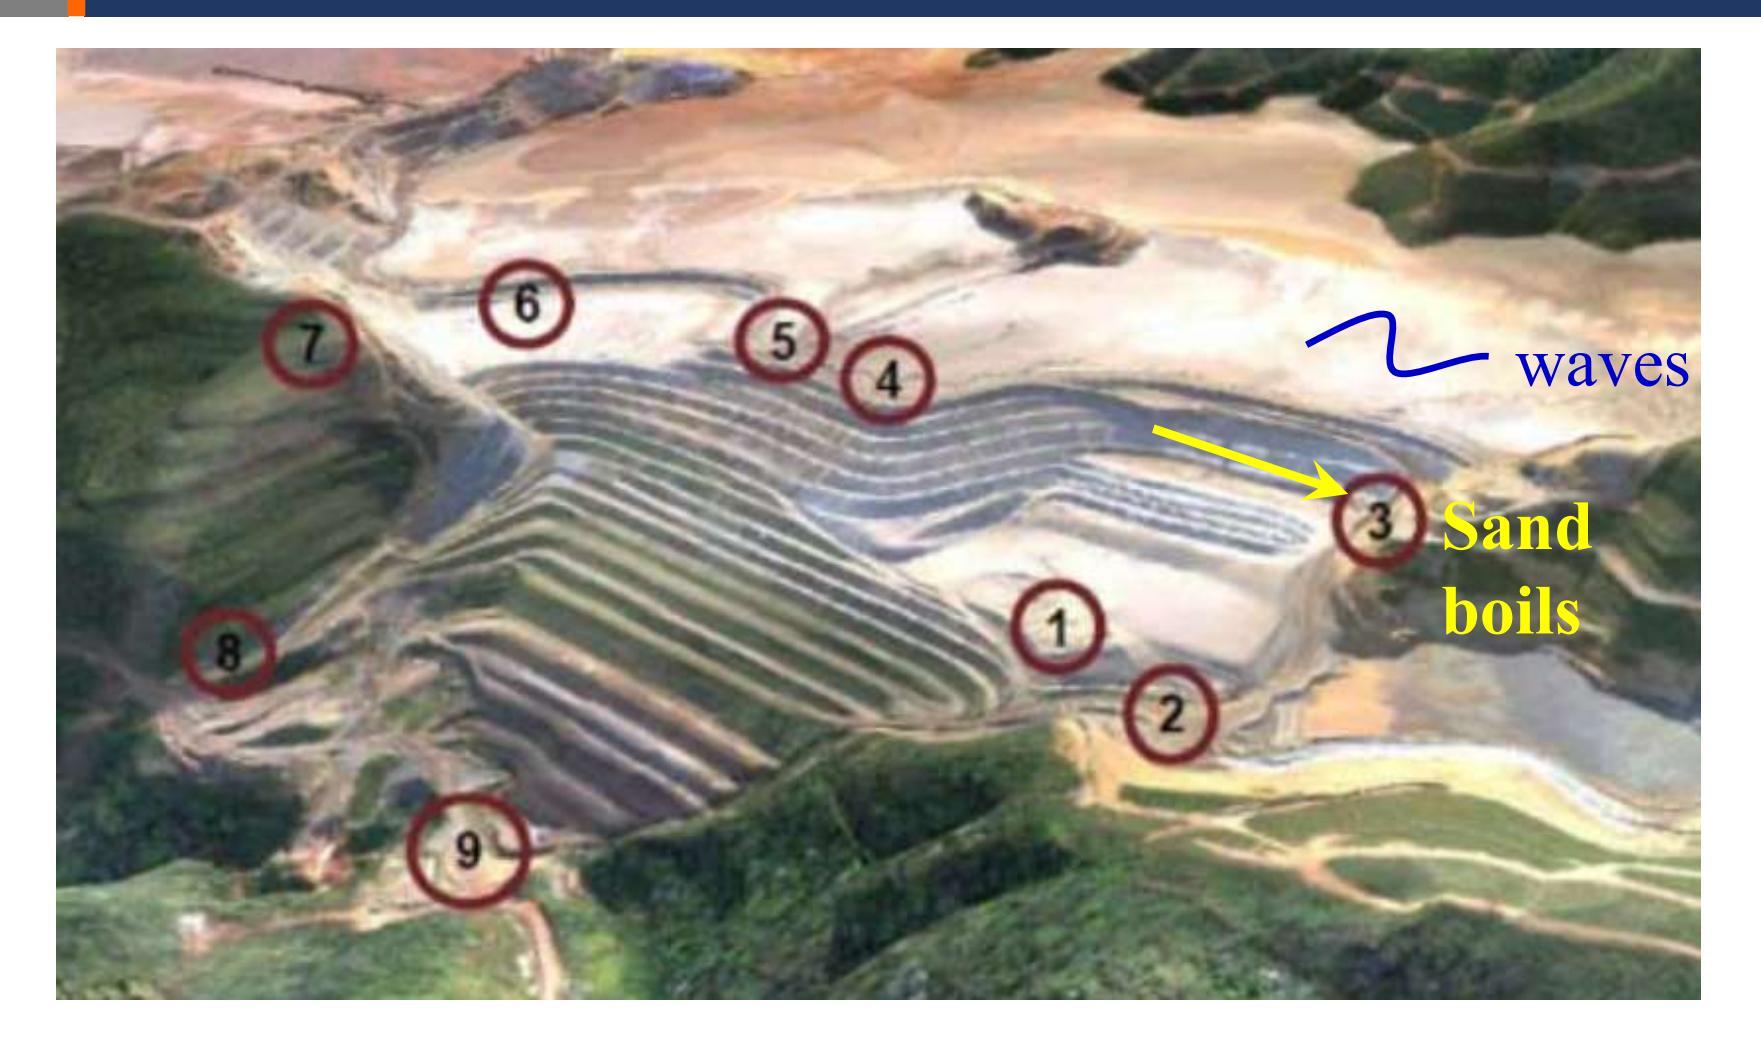
Witness Location and Description

#4: waves developed in the central portion of the reservoir, accompanied by cracks forming on the left side and blocks of sand moving up and down on the left abutment setback

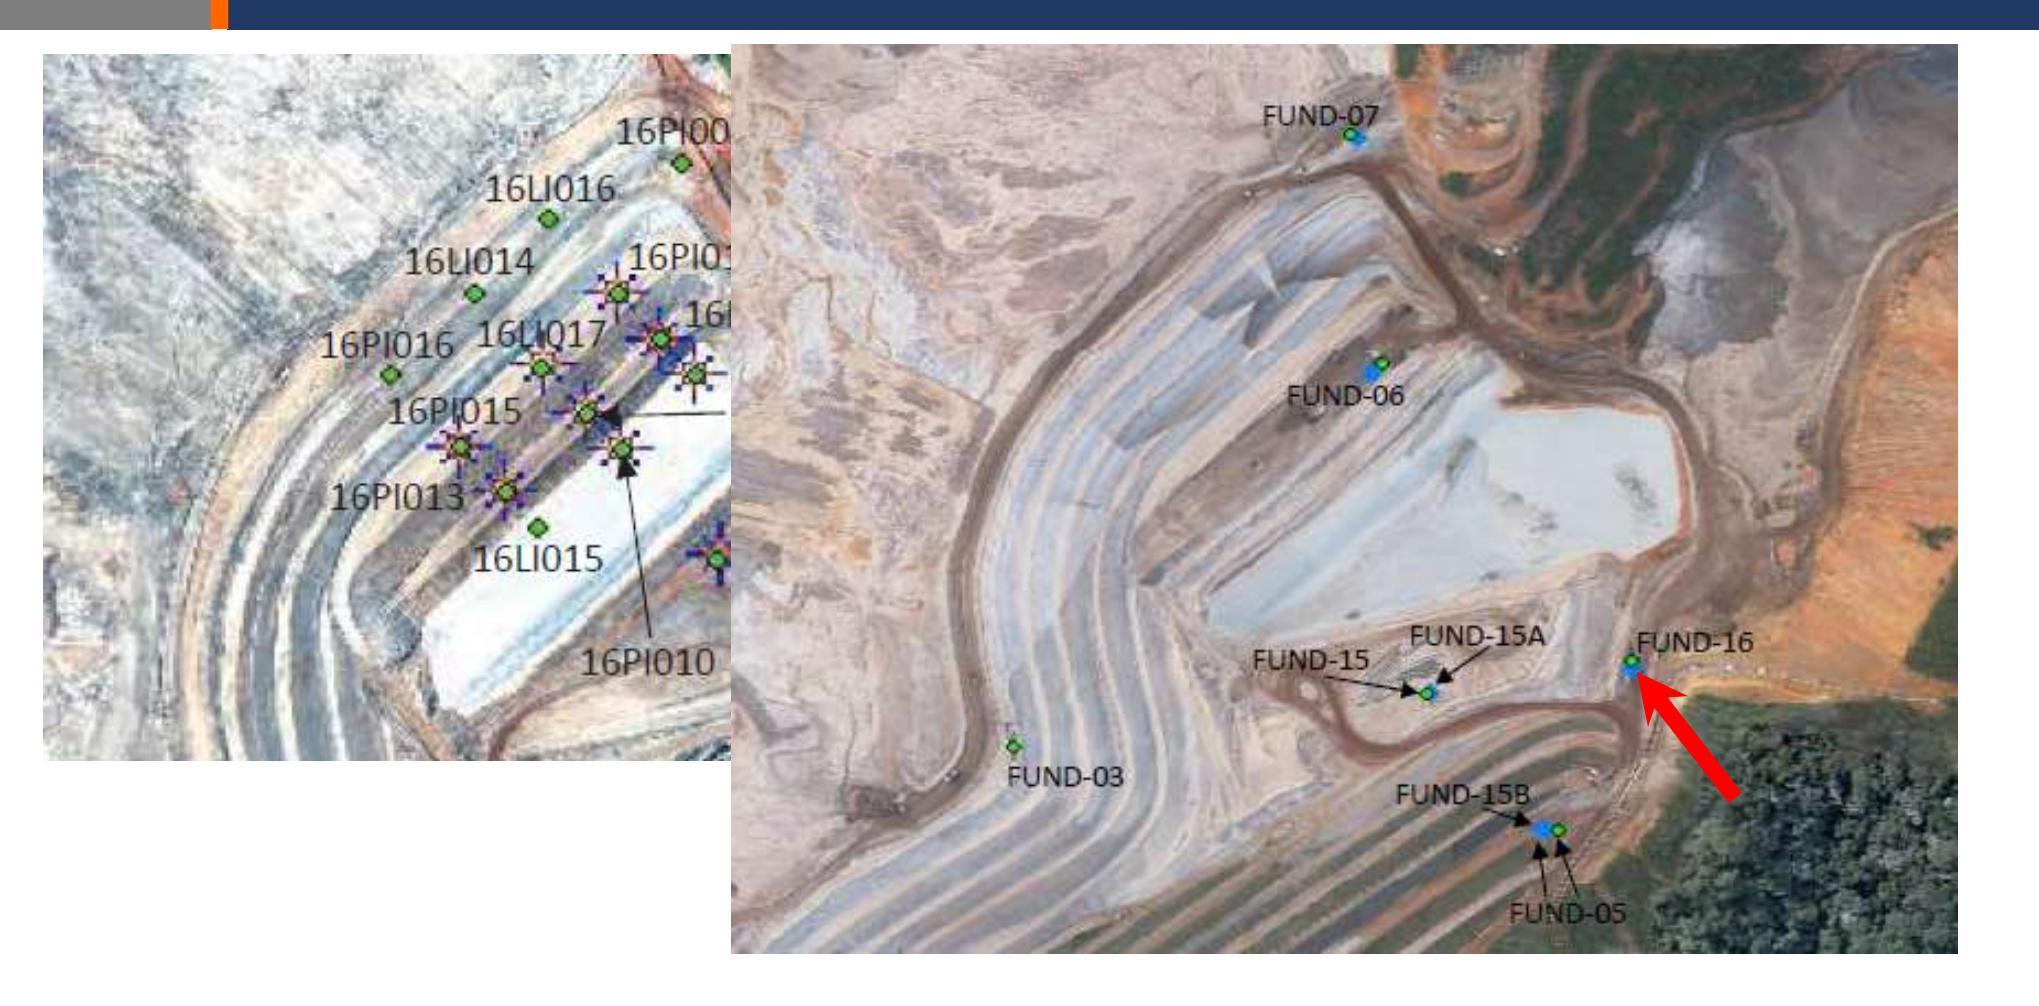
Pre-Failure CPT Data-FUND 16-CPT

Tailings Sand_{Toe}:

- Apparent fines content ~ 10% & Depth = 3.76 m

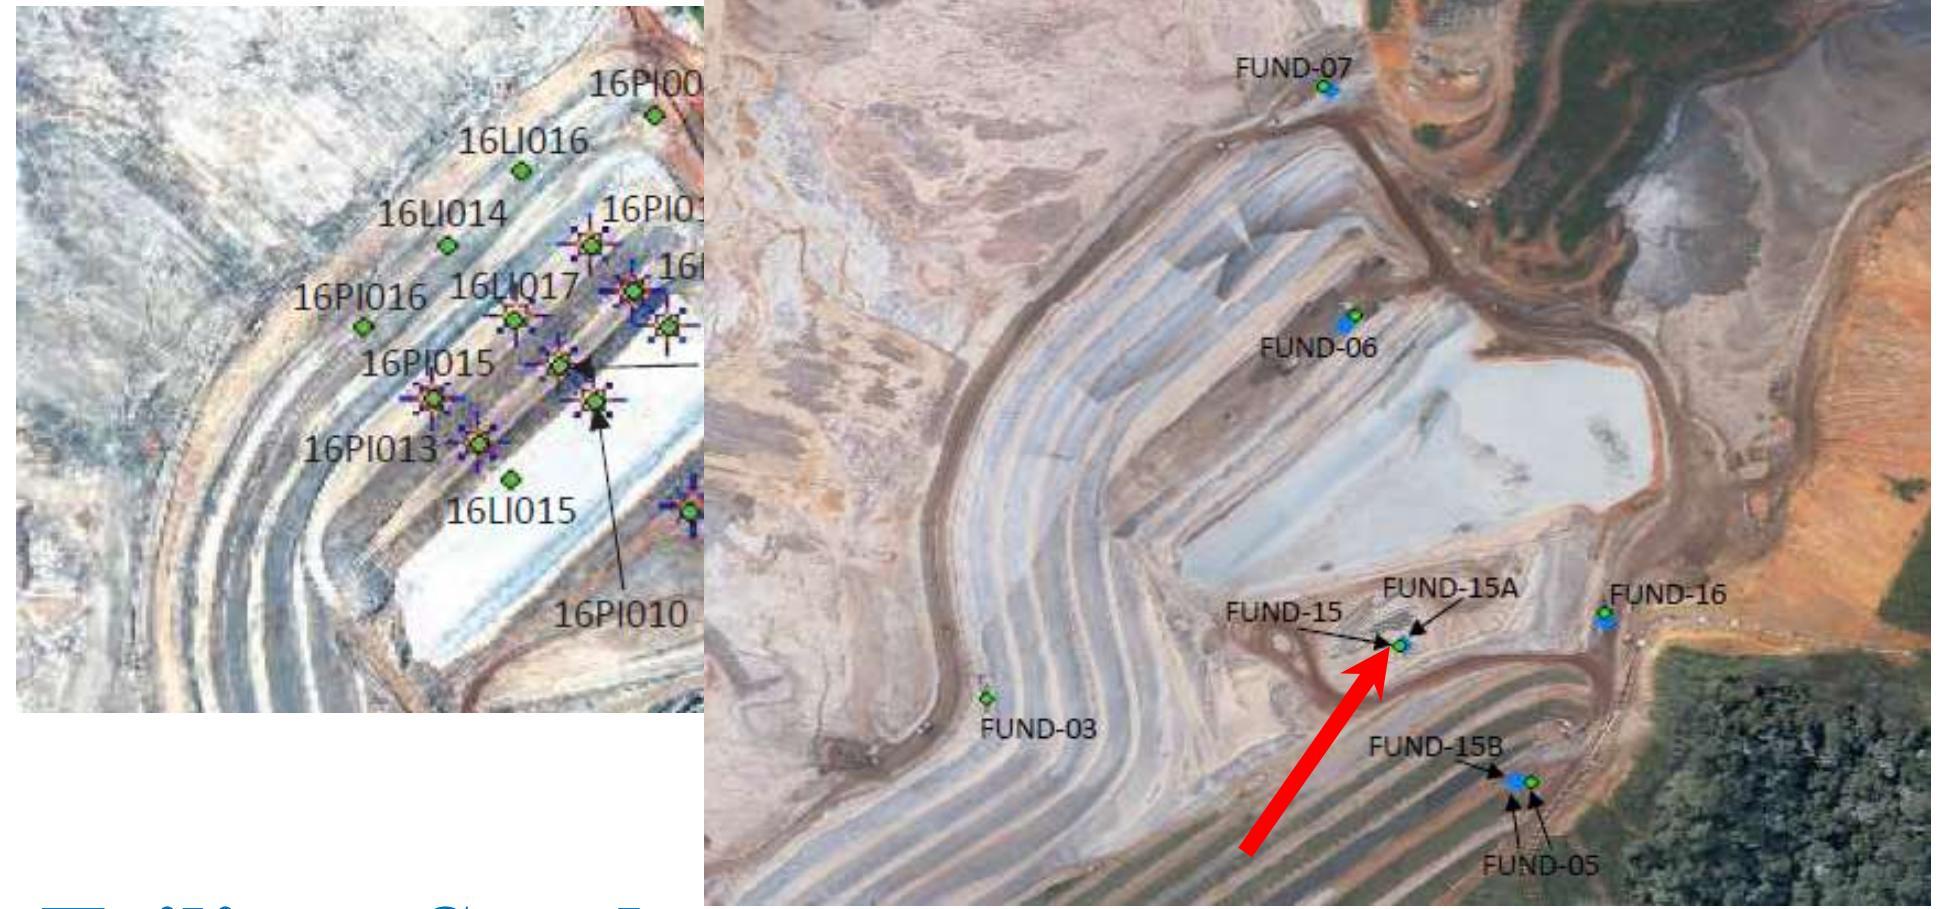
Pre-Failure SPT Data-FUND 15-SPT

Tailings Sand_{Plateau}:

- Apparent fines content $\sim 10\%$
- Clay size fraction < 2% (Morgenstern et al., 2016)
- Silt deposit has no cohesion

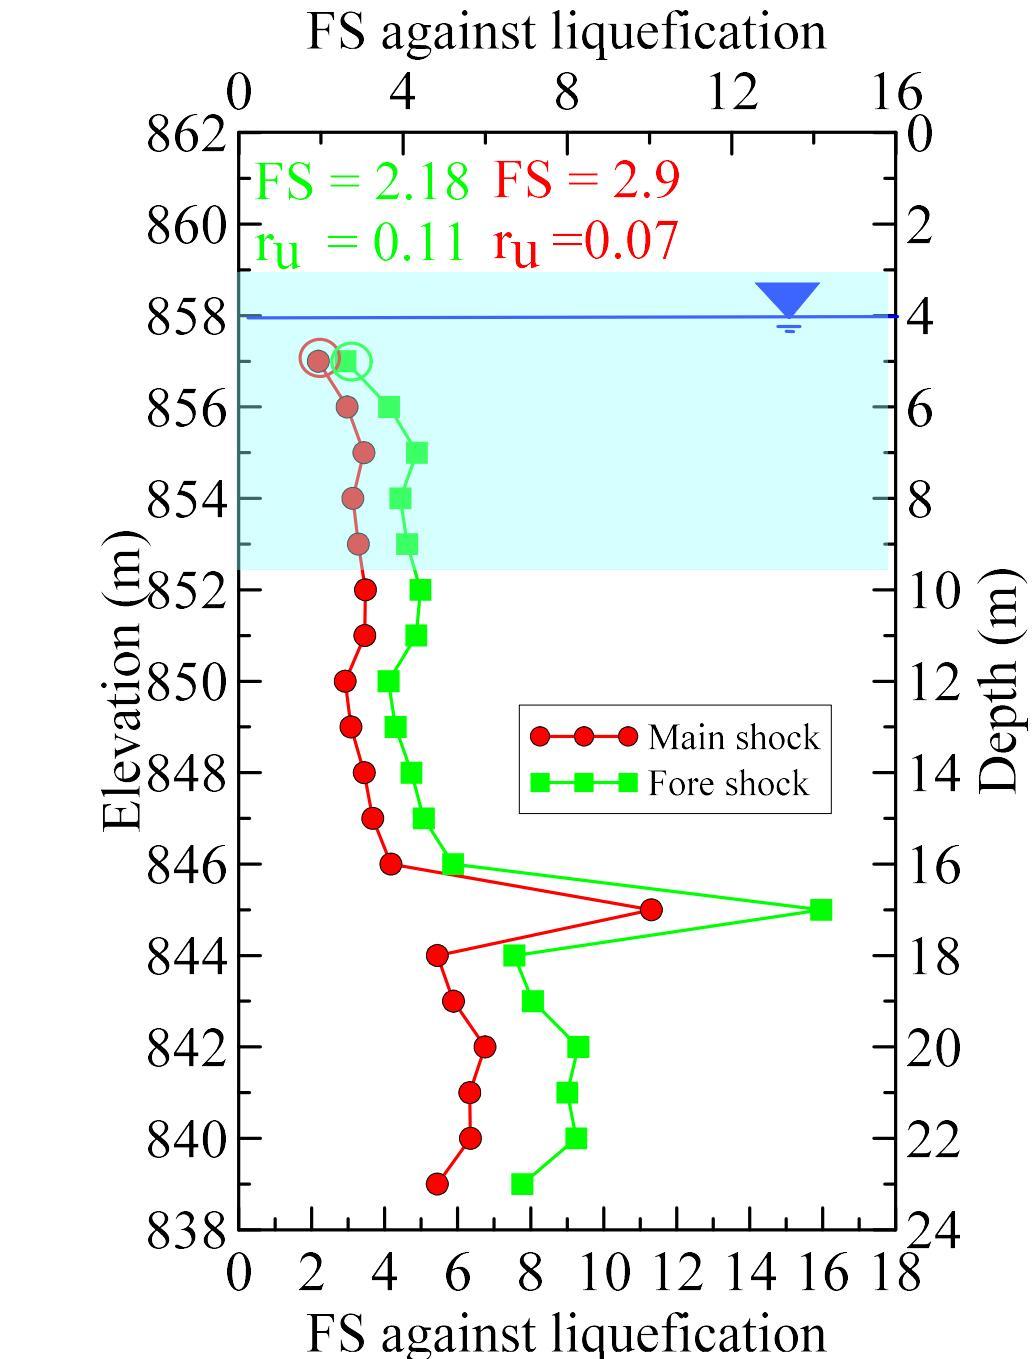
Pre-Failure SPT Data-FUND 15-SPT

Sand_{Plateau} Depth = 5.0 mFS>1.5

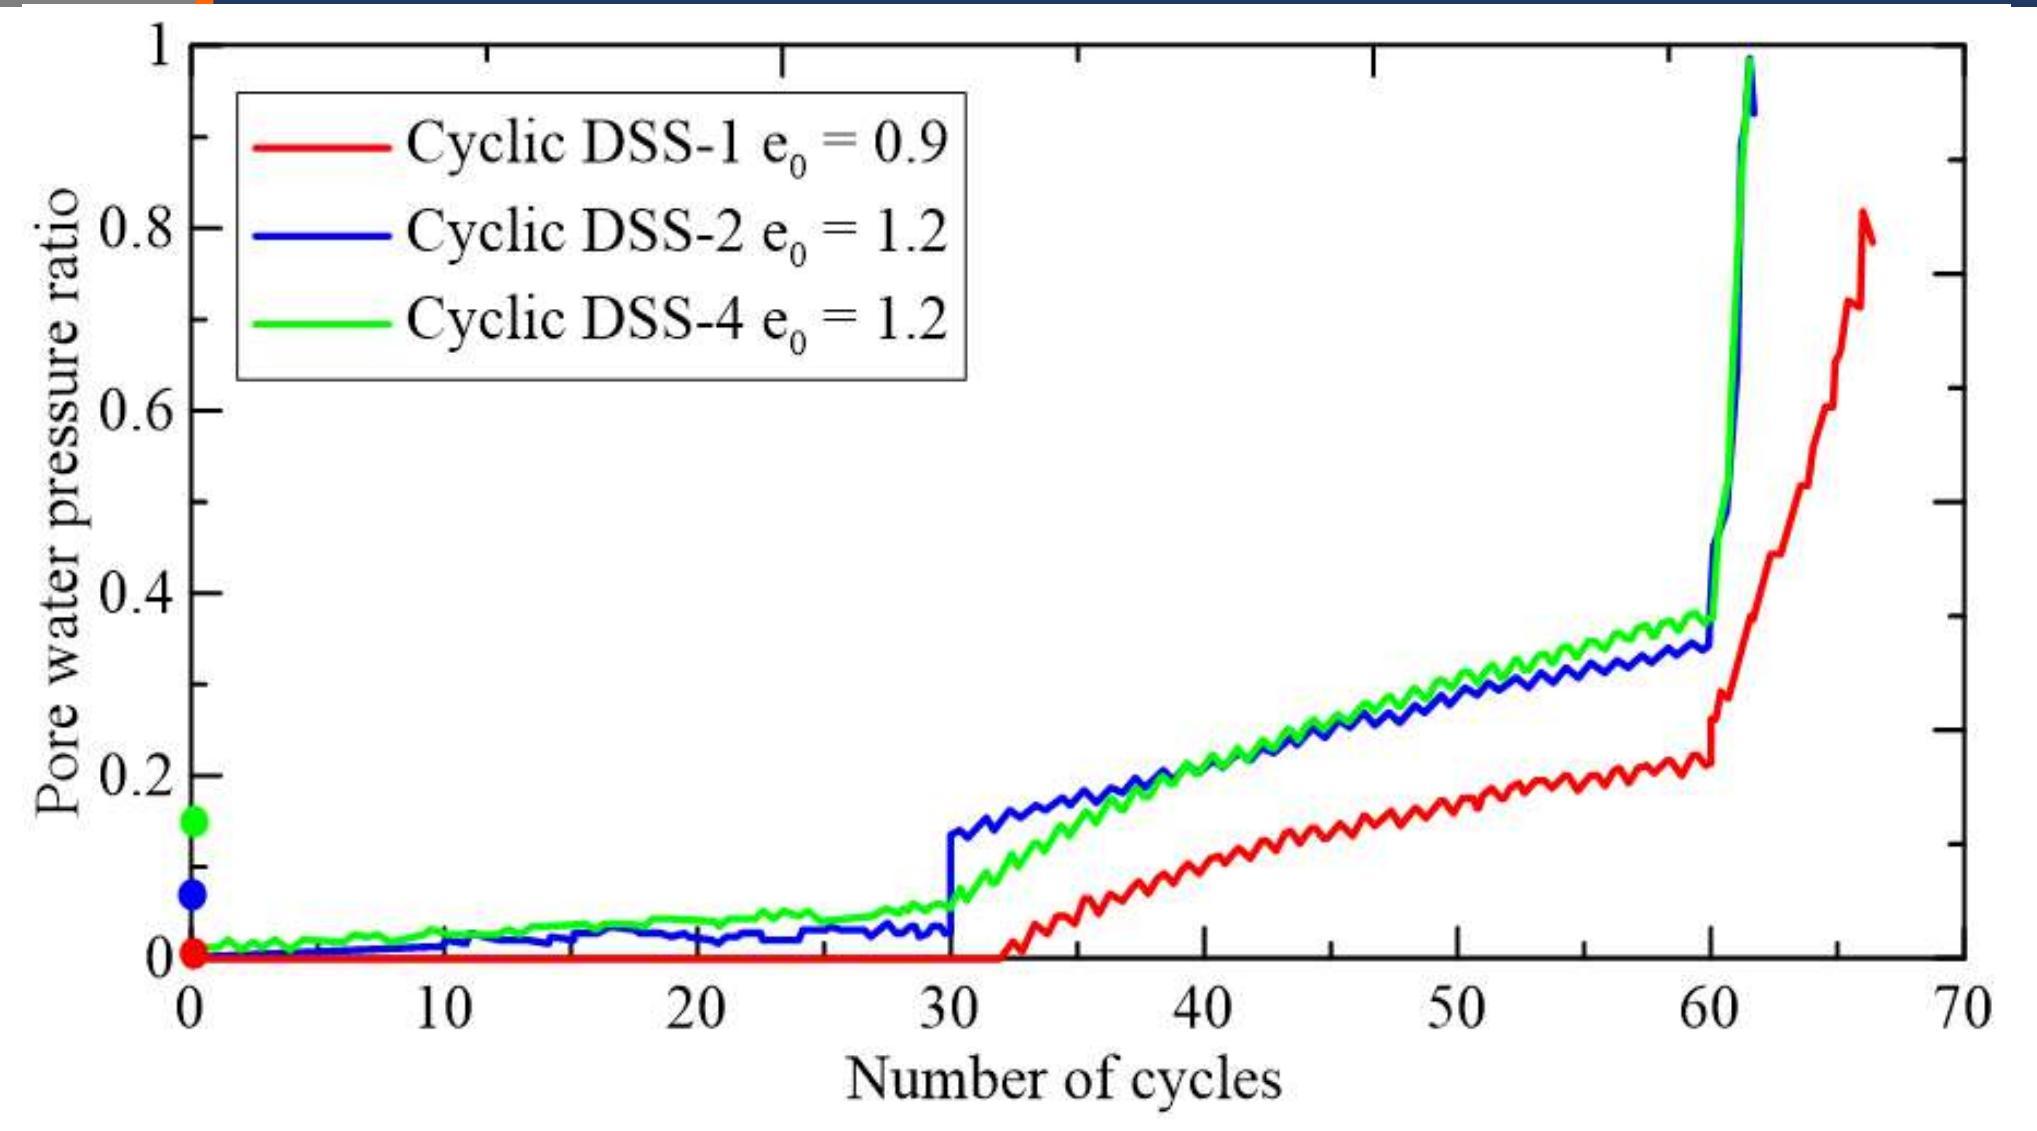
Cyclic Direct Simple Shear Testis – Attachment D5

• 0 to 30 cycles -CSR = 0.01 = 10*CSR at Slimes

- 30 to 60 cycles CSR = 0.05 \sim CSR at Left Abutment Setback
- 60 to 90 cycles CSR = 0.1 \sim Panel CSR
