Tailings Closure: Planning, Implementation and Lessons Learned

Prof David Williams

Tailings Dams Rehabilitation and Closure at San Manuel, Arizona, USA

Capping Surface and In-Pit Tailings at New Acland Coal Mine, South-East Queensland

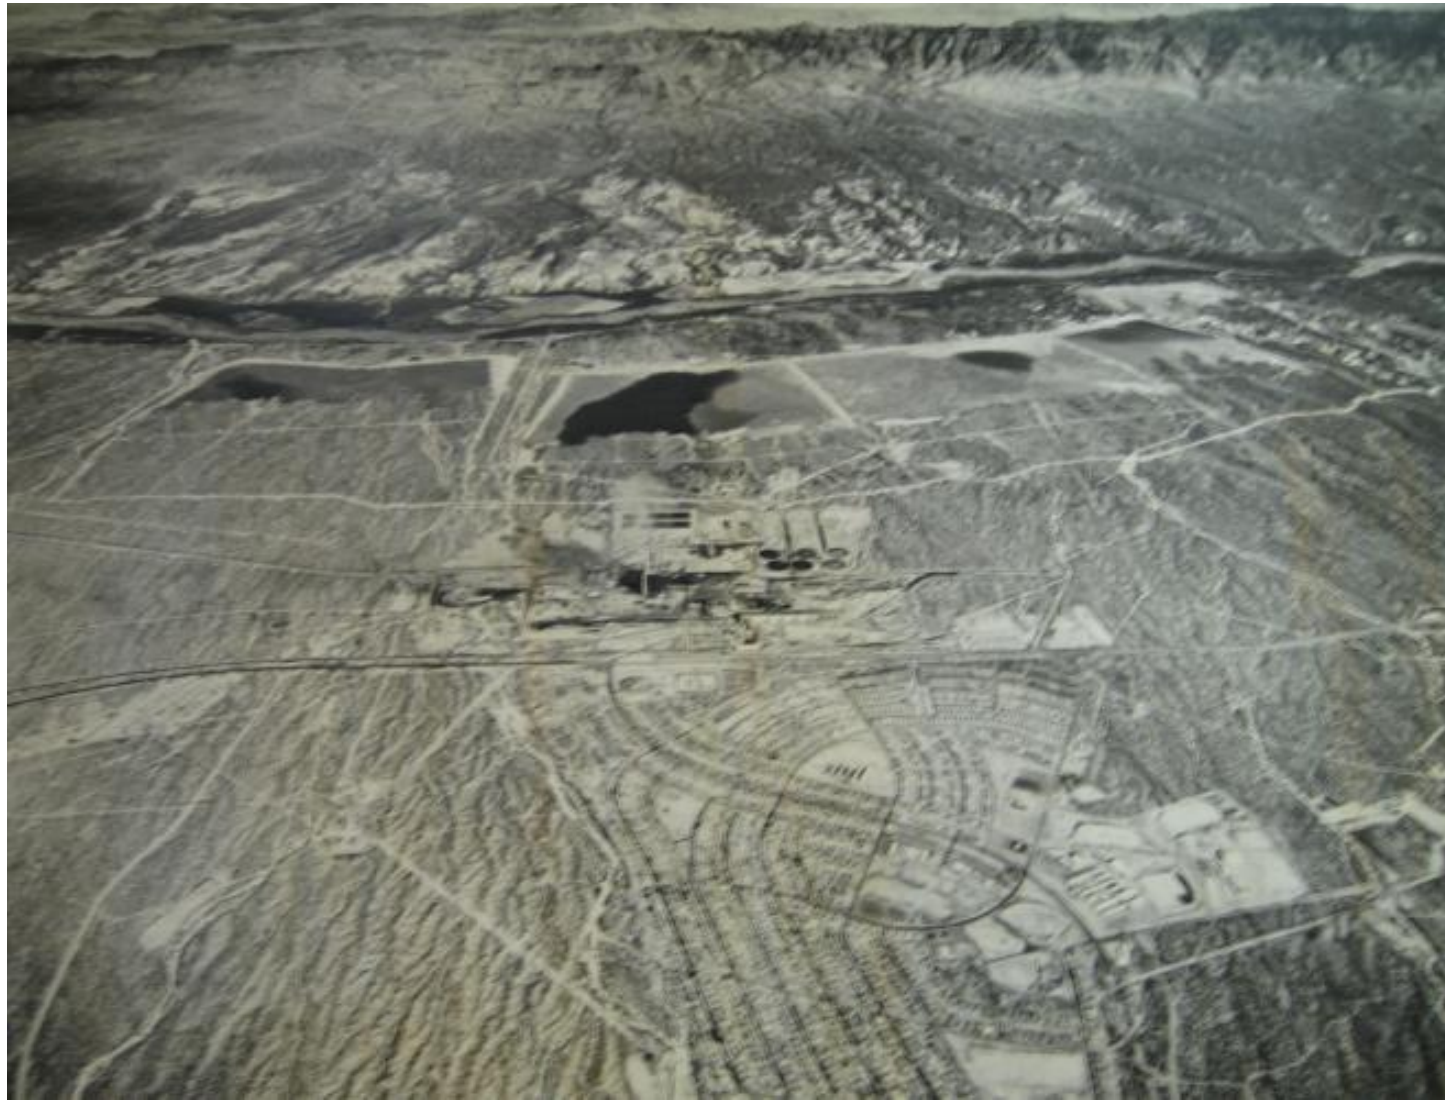
San Manuel Tailings Dams During Operation – Early 1970s

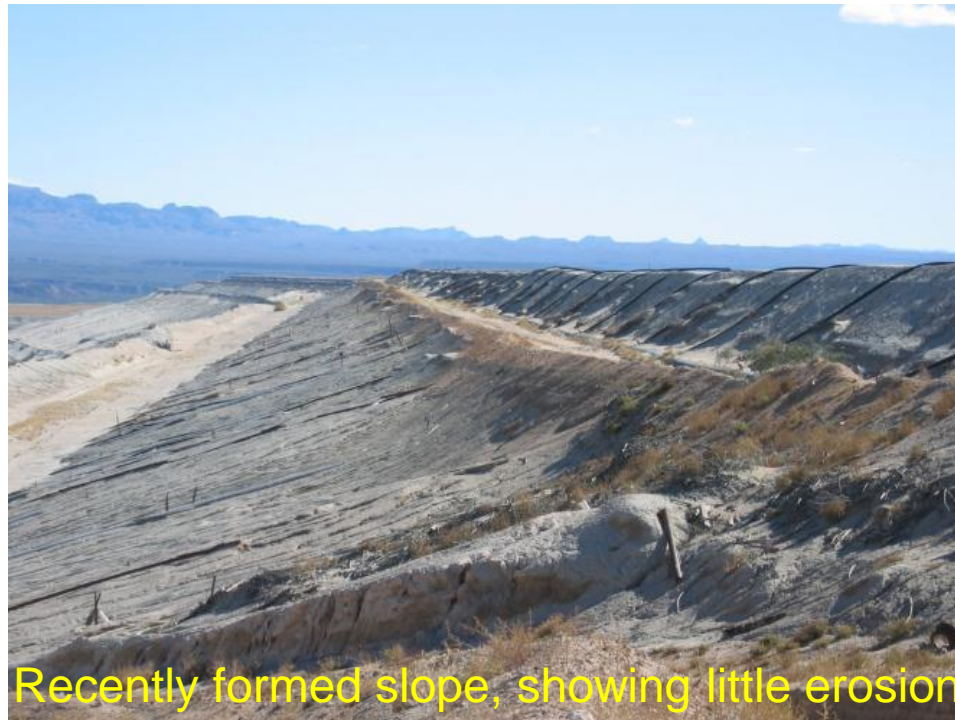
Unrehabilitated, (Cycloned) Coarse-Grained Tailings Slope

- San Manuel's outer tailings slopes in Arizona's arid climate showed them to be prone to piping erosion
- Covers of natural fine and coarse-grained alluvium showed that alluvium suffered a washout of fines and sand during storms, leading to eventual loss of cover and piping erosion of exposed tailings
- Unless they are cemented or overlain by a dense, coarse-grained cap, natural alluvial slopes are also prone to erosion by storms

- Outer slopes of San Manuel tailings storages show gullying developed from **tunnel erosion of tailings**, which appears to follow sequence:
 - Initiation and development of tunnel erosion in tailings
 - Emergence of erosion tunnels downslope
 - Collapse of tunnels leading to gullies
 - Progression of gullies, ultimately extending over full slope height

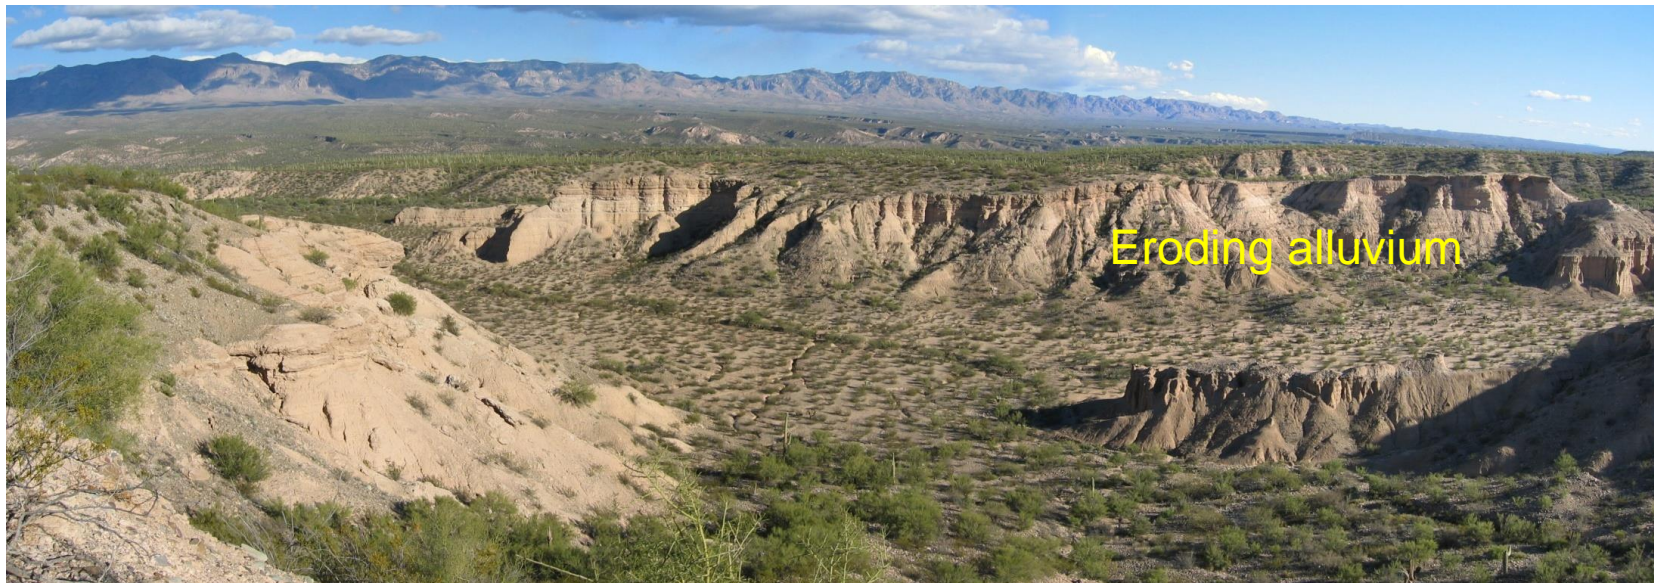
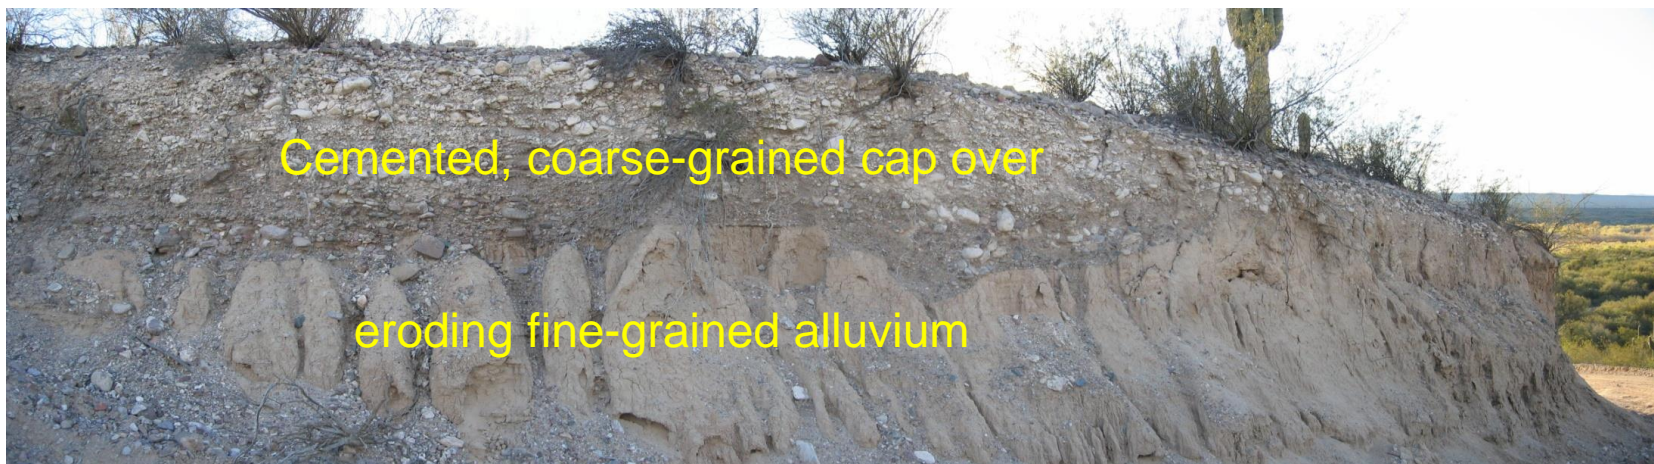
Performance of Natural Alluvium Landforms

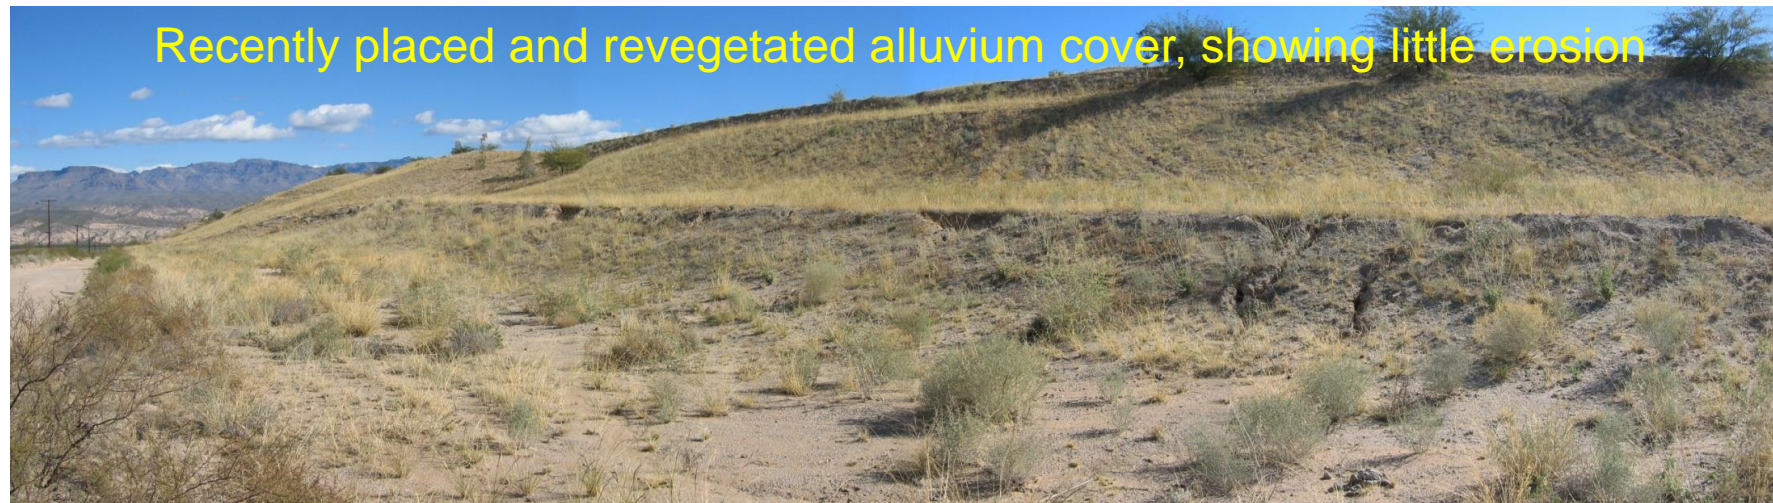
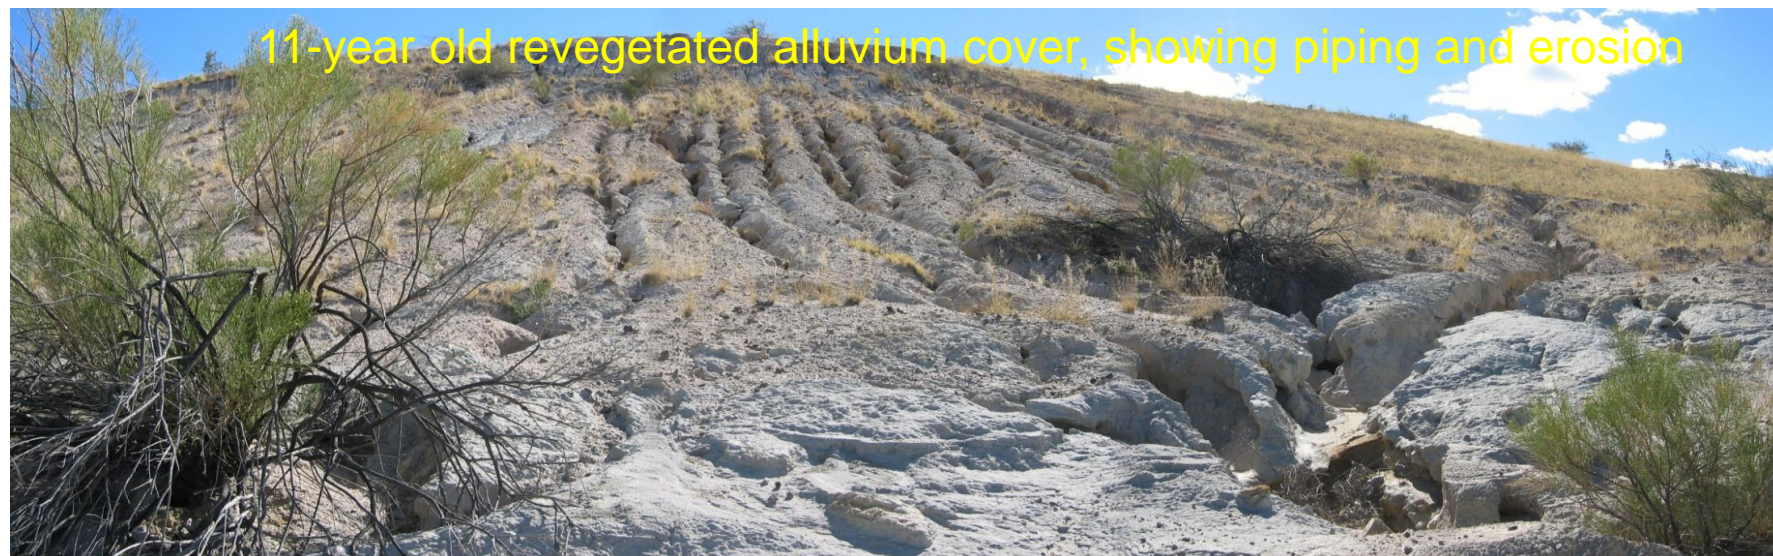
Performance of Revegetated Alluvium Cover Over Time

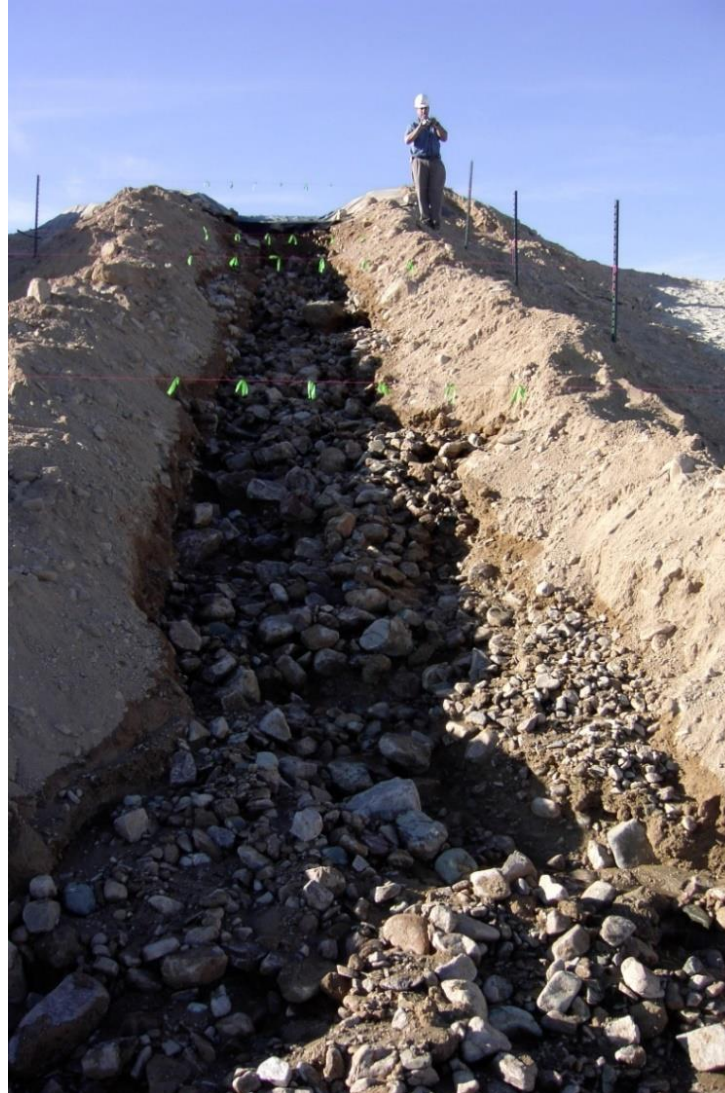
Coarse-grained alluvium – showing extensive wash-out

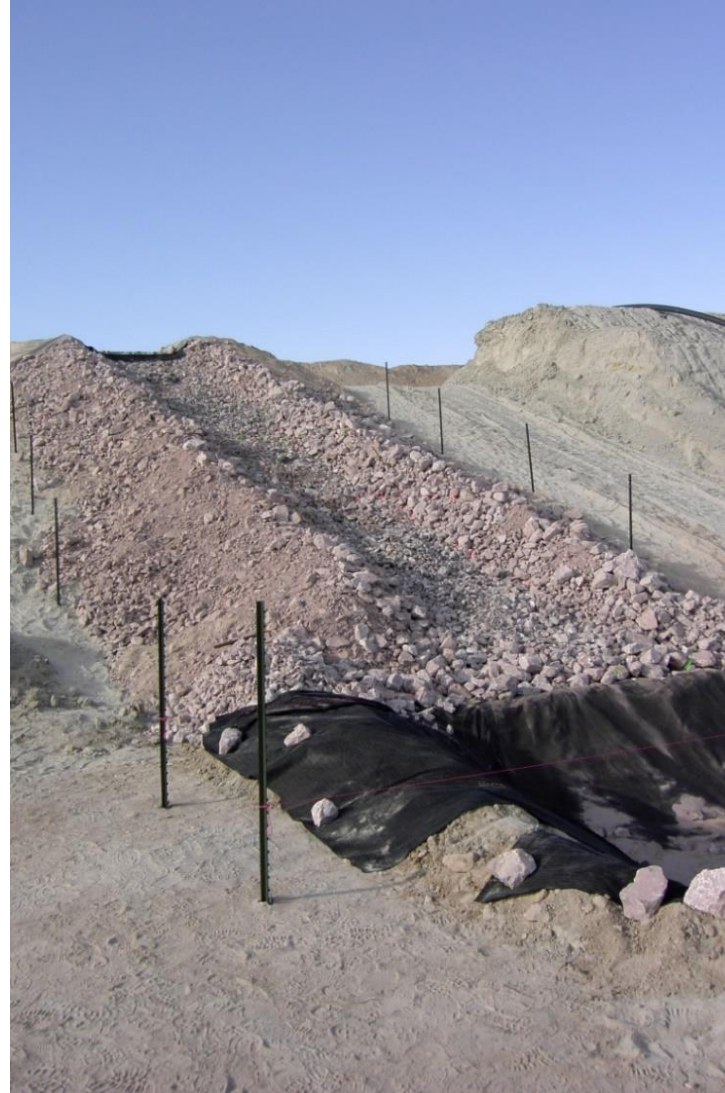
Rip rap – showing negligible erosion

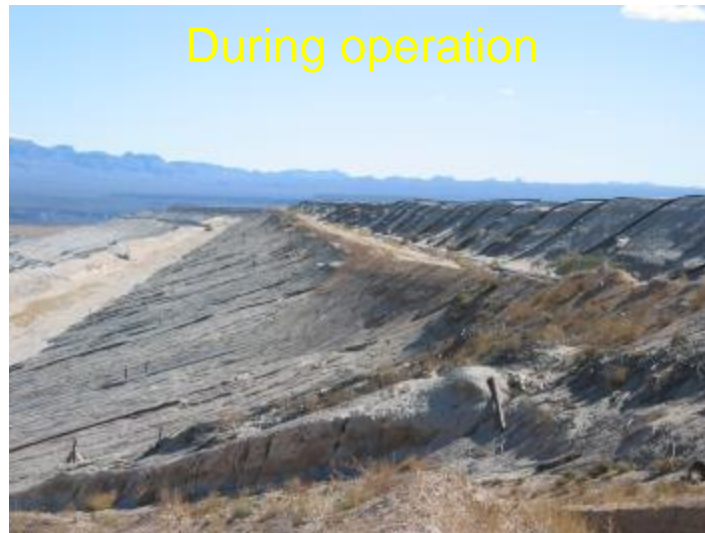
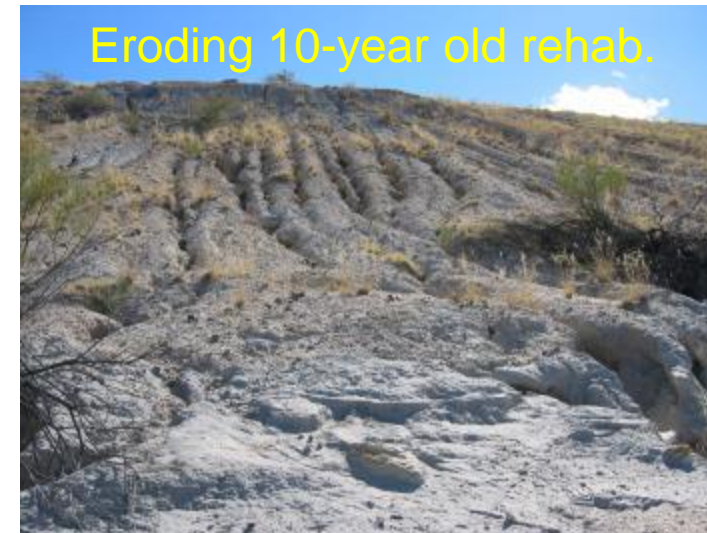
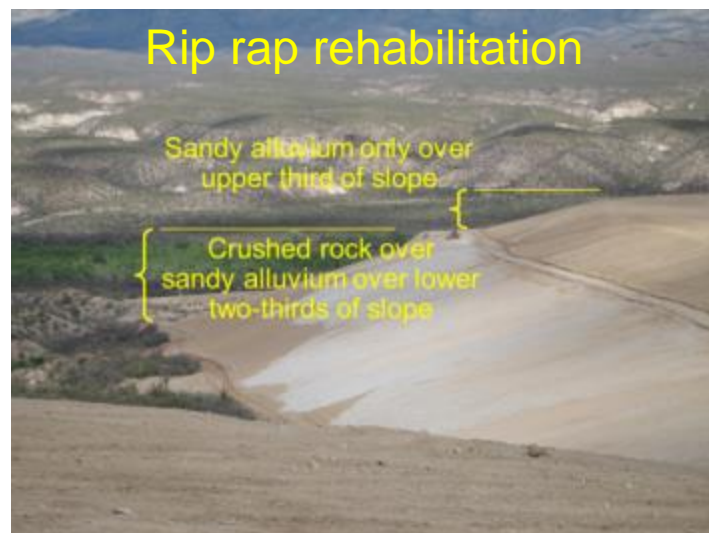
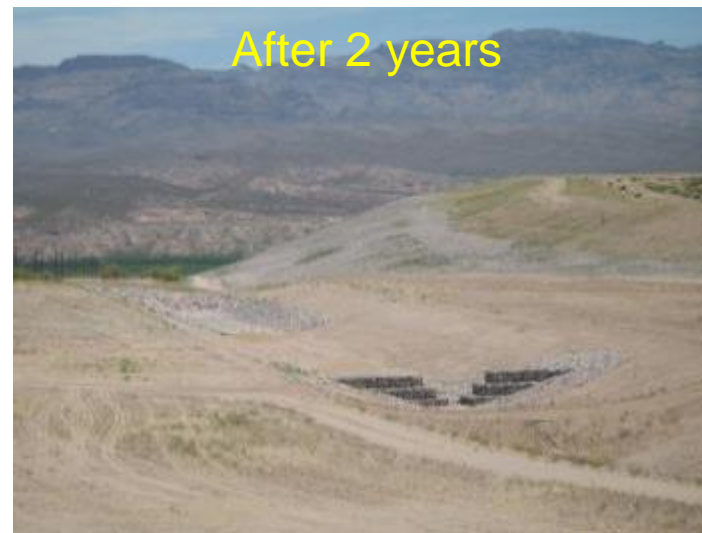
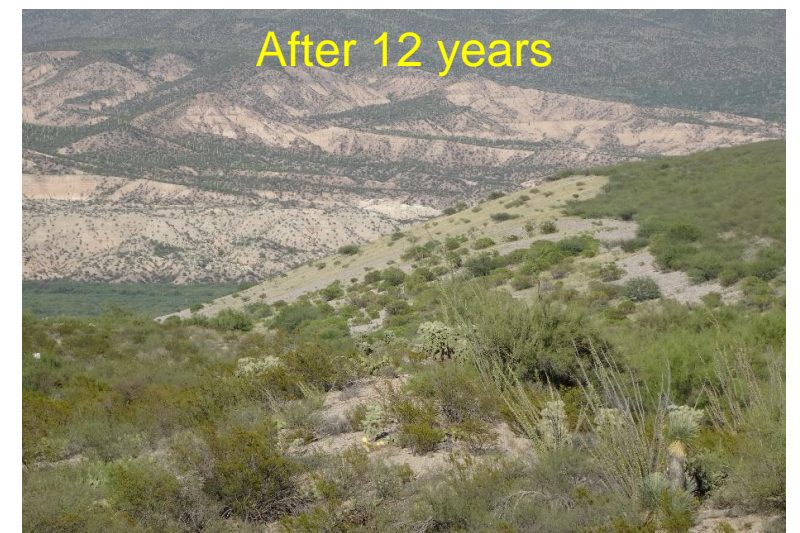
Successful Rip Rap Rehab. of 100 m High, Benign TSF Slope

- Continuous 3:1 slope
- 0.3 m fine-grained alluvium over entire slope
- 230 mm of rip rap erosion protection over lower 2/3
- No drainage benches or downslope drains, and no reliance on reveg. of rip rap
- 0.3 m of coarse-grained alluvium over upper 1/3

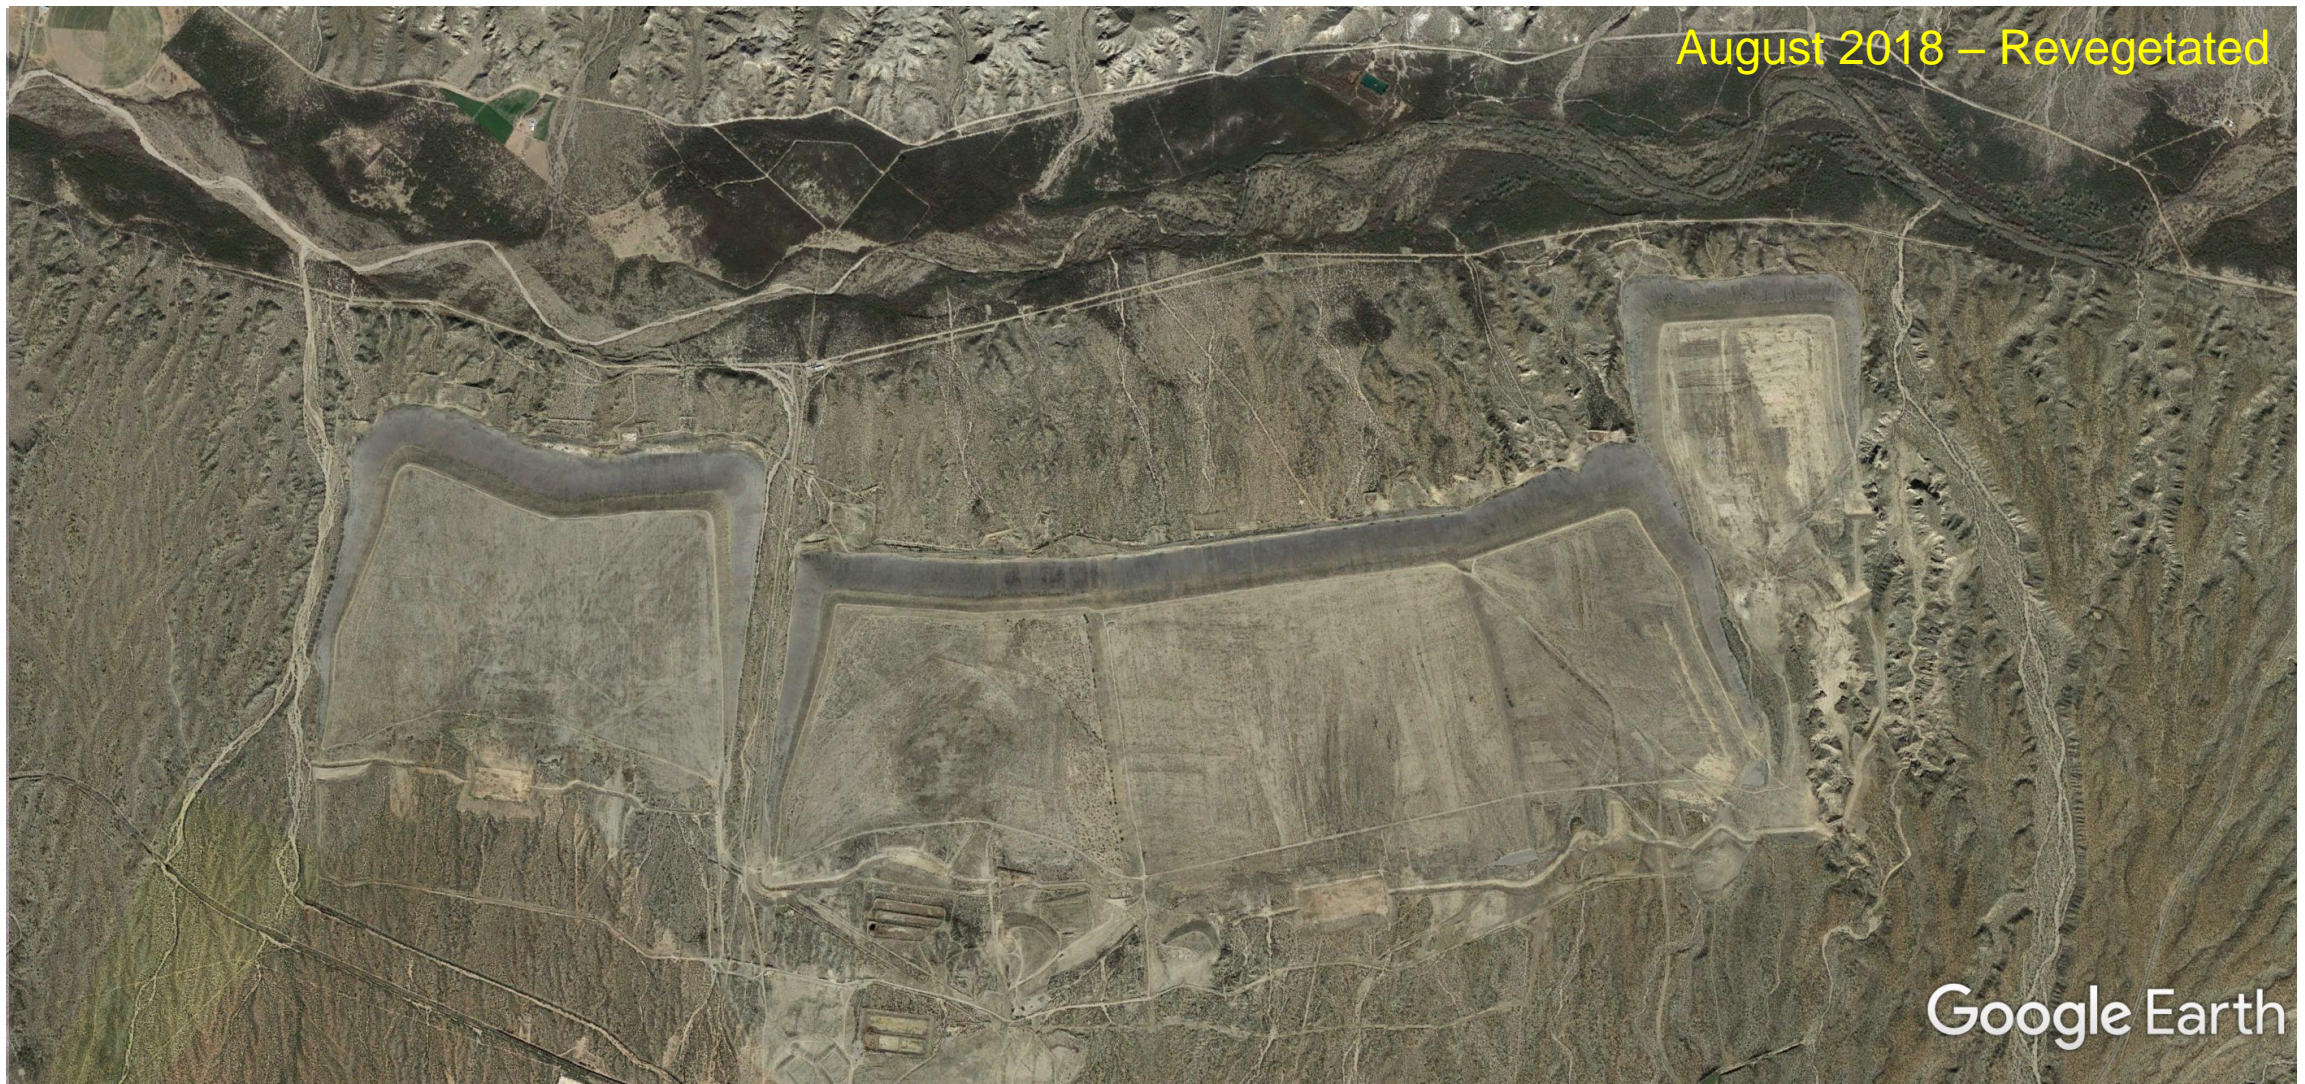
Rock Cover on Tailings – San Manuel, Arizona, USA

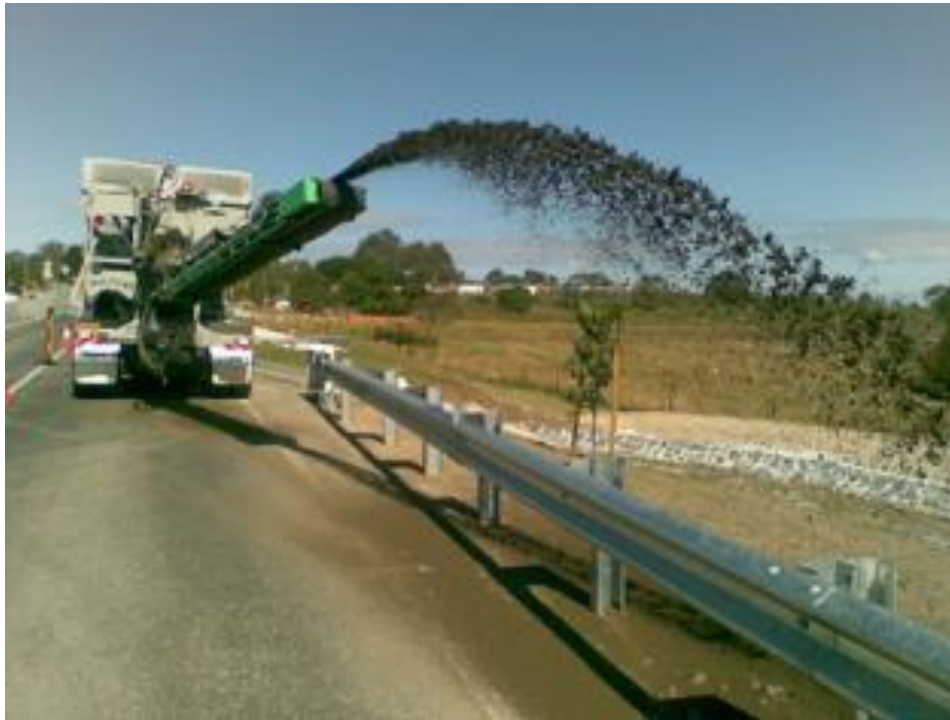
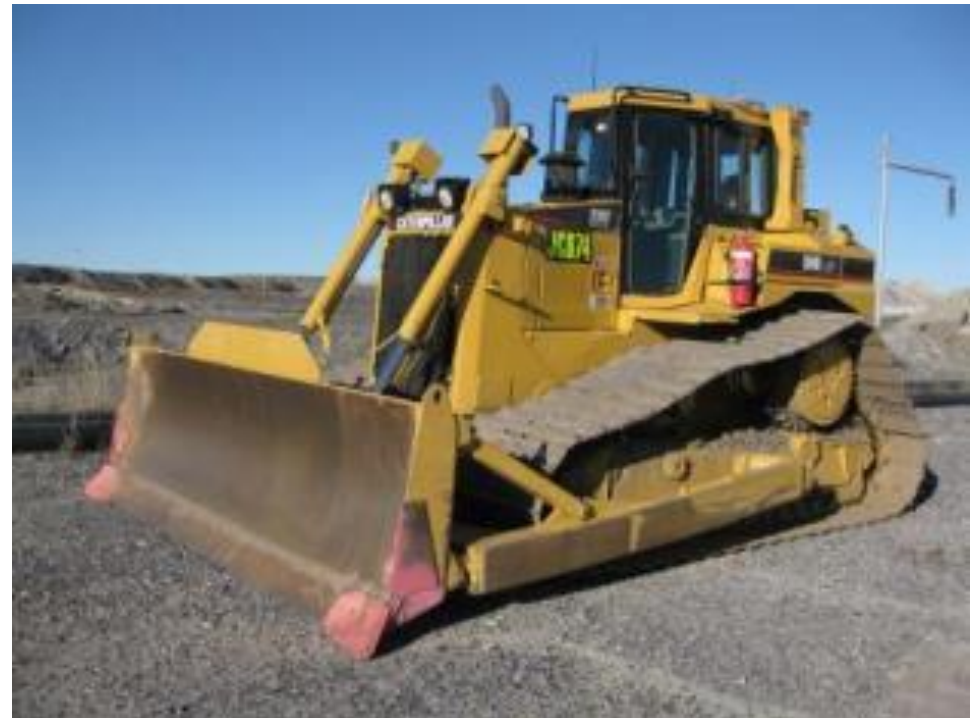
Rockslinger versus D6 Swamp Dozer Push

- Coarse reject was proposed as capping material, being better-draining than spoil, which degrades rapidly
- Overall cover was to comprise an initial ~1 m capping layer of coarse reject, followed by a second 2 to 3 m thick layer of coarse reject and/or spoil, and finally a topsoil layer that was to be seeded and fertilised
- Possible capping methods:
 - Place coarse reject hydraulically, which was dismissed due to infrastructure required
 - Place coarse reject by a Rockslinger, which was trialled and found to have insufficient reach
 - Push coarse reject by D6 Swamp Dozer, which was adopted (D6 Swamp Dozer exerts an average track bearing pressure of 35 kPa, equivalent to ~1 m height of fill)

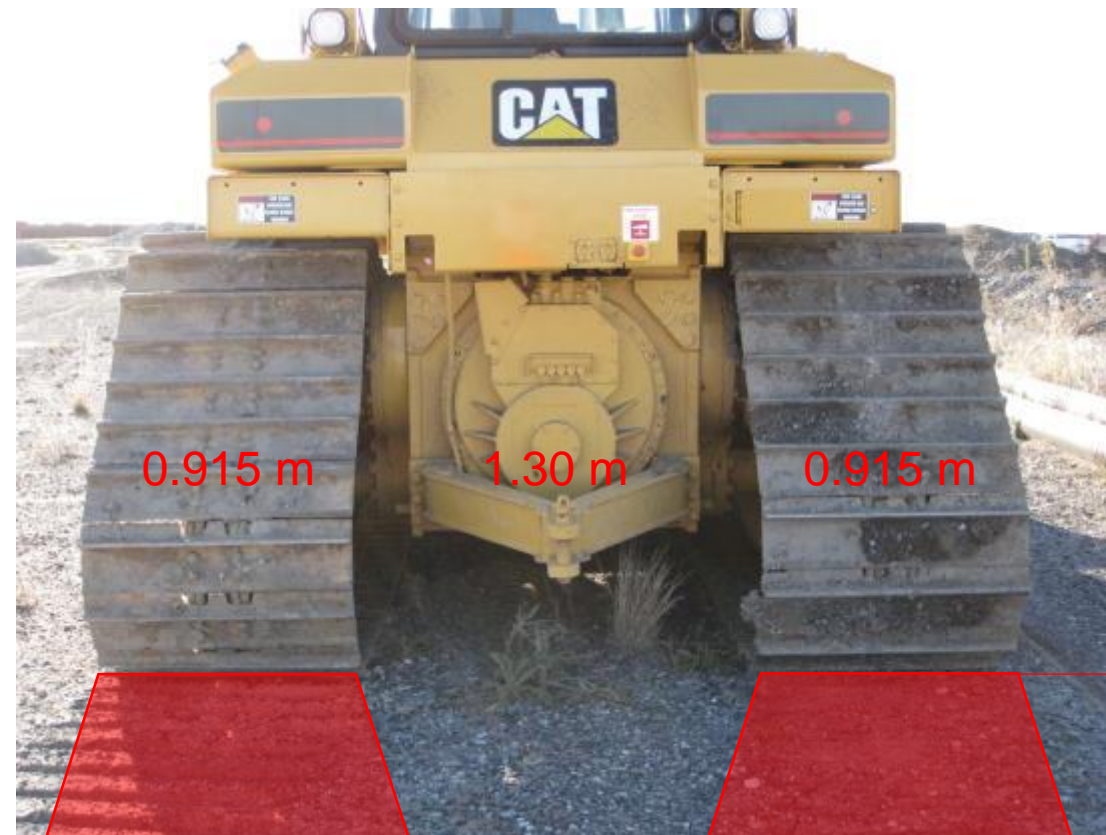
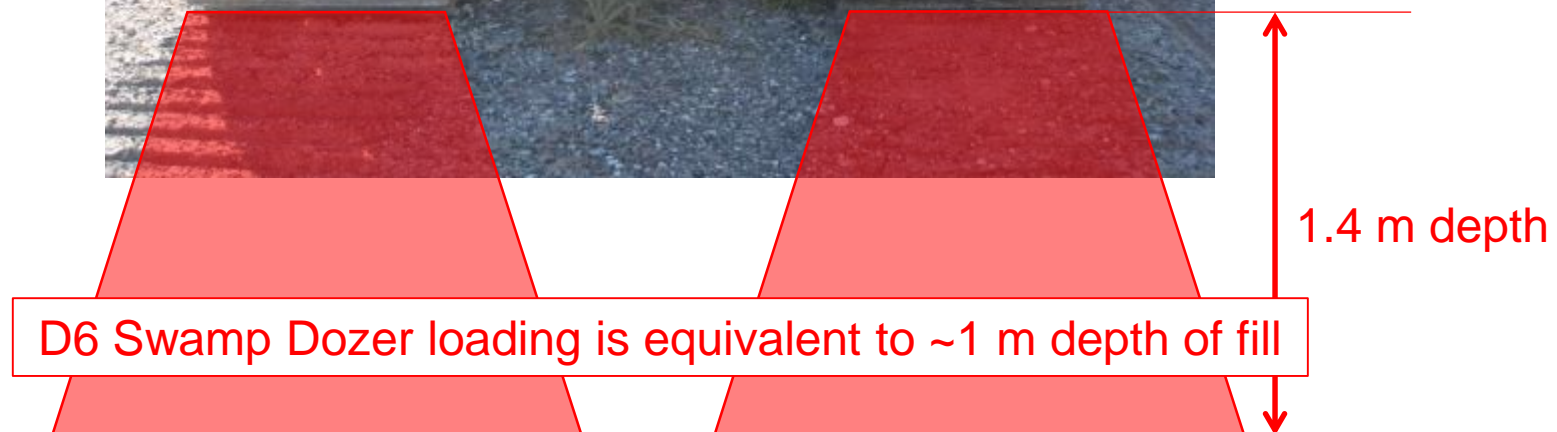
D6 Swamp Dozer – Dispersion of Bearing Pressure

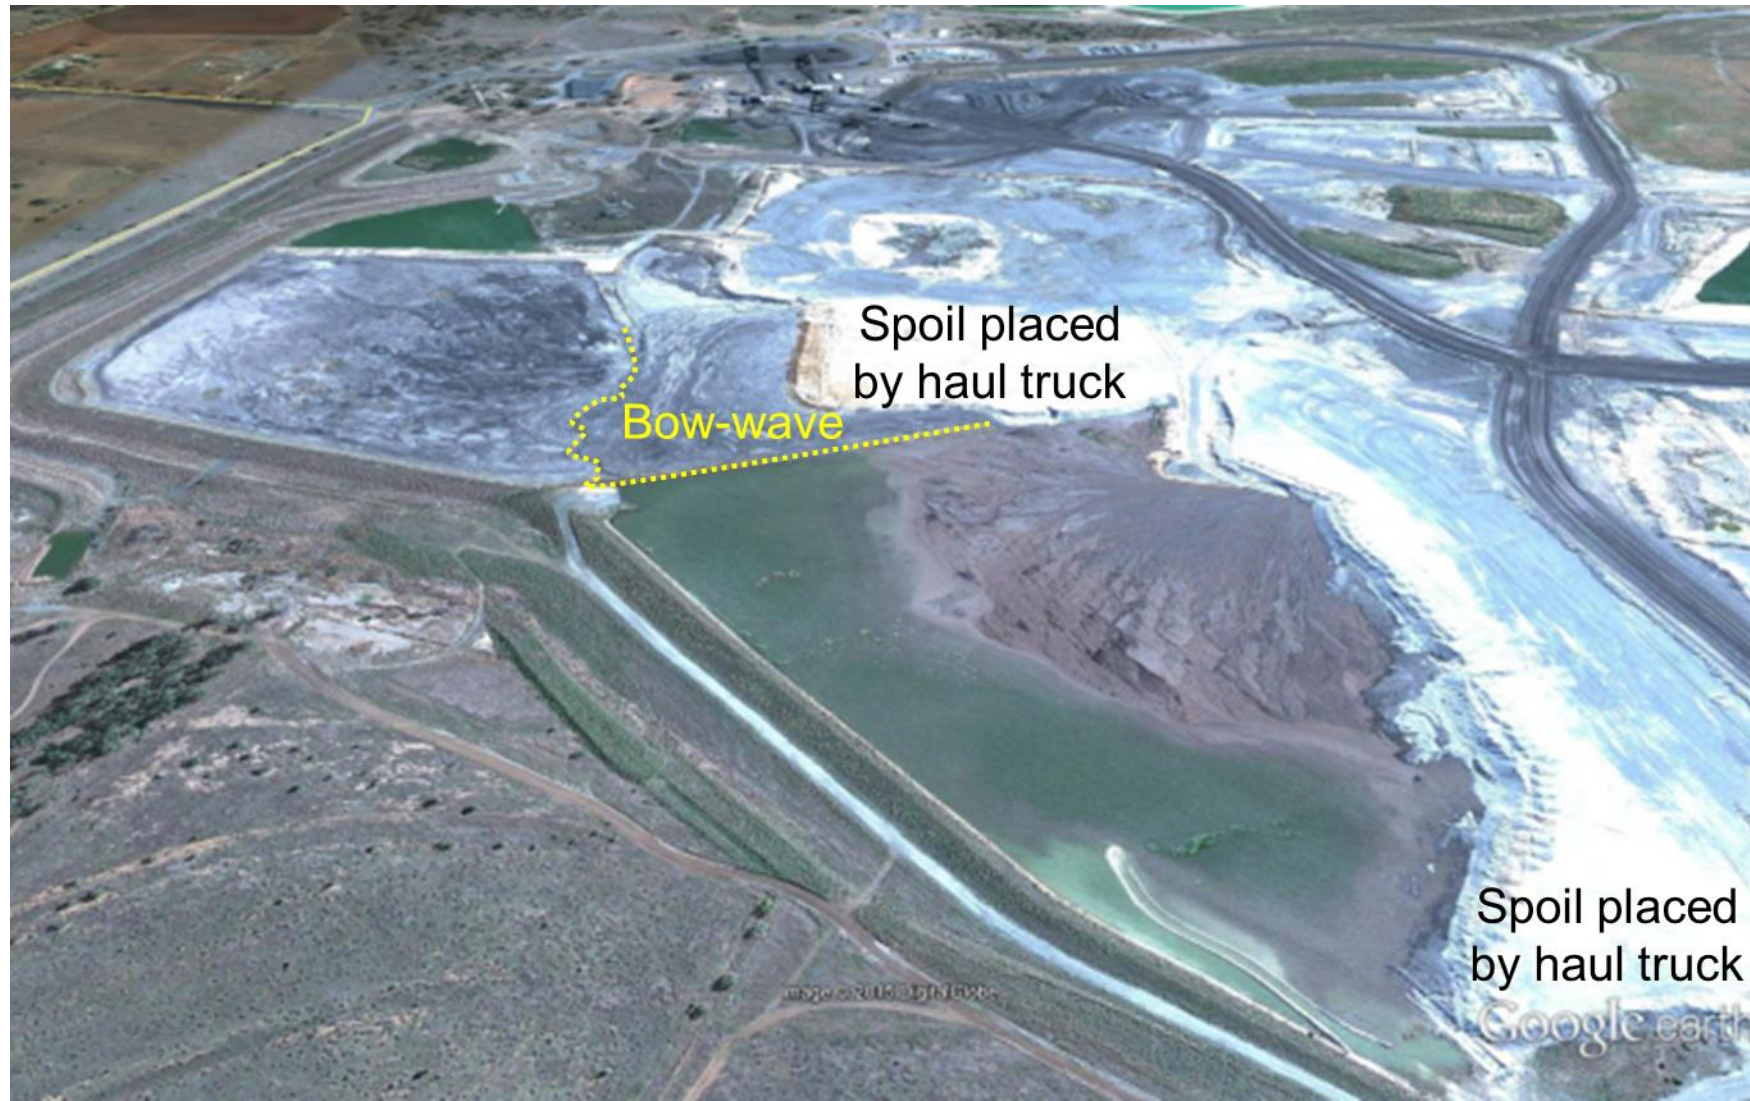
Surface TSF in August 2009 – Uncontrolled Capping

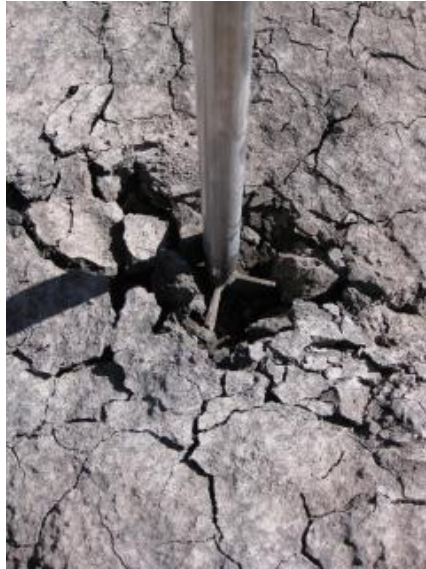
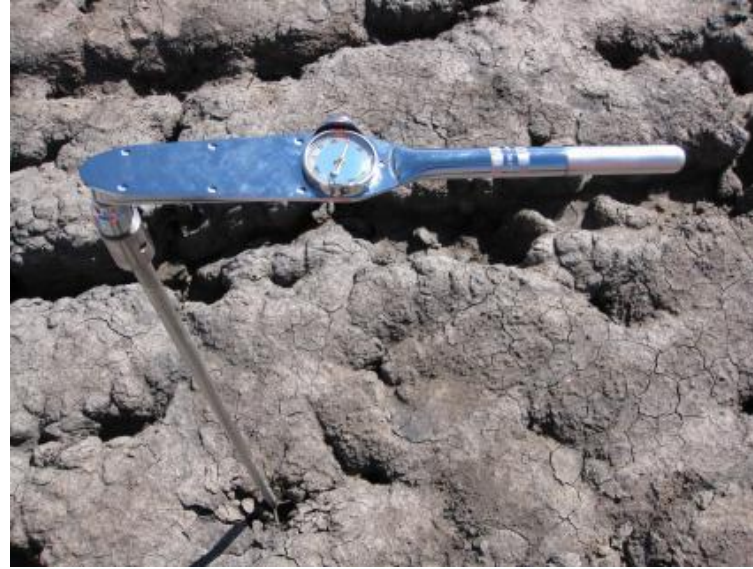
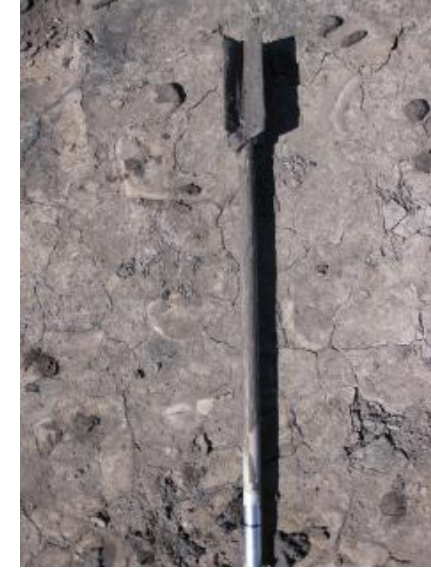
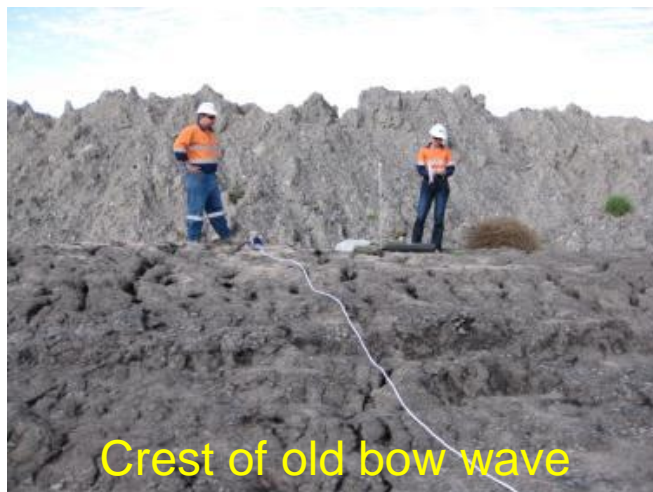
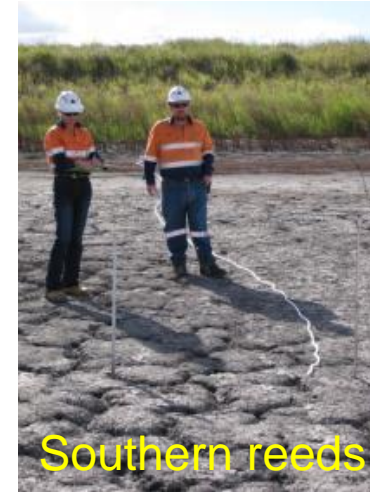
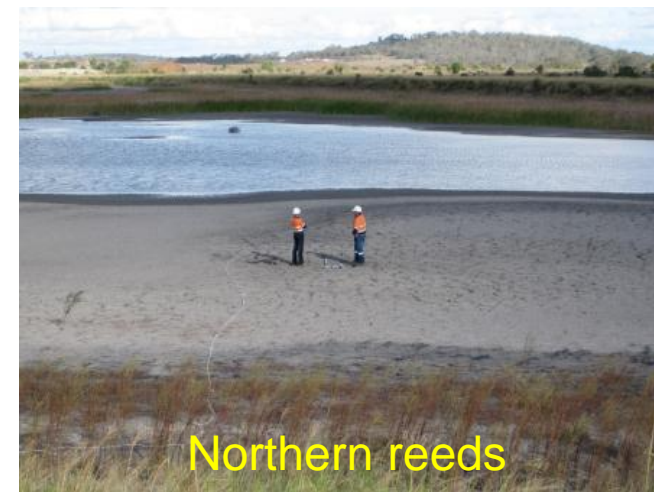
Vane Shear Testing of Crusted Tailings

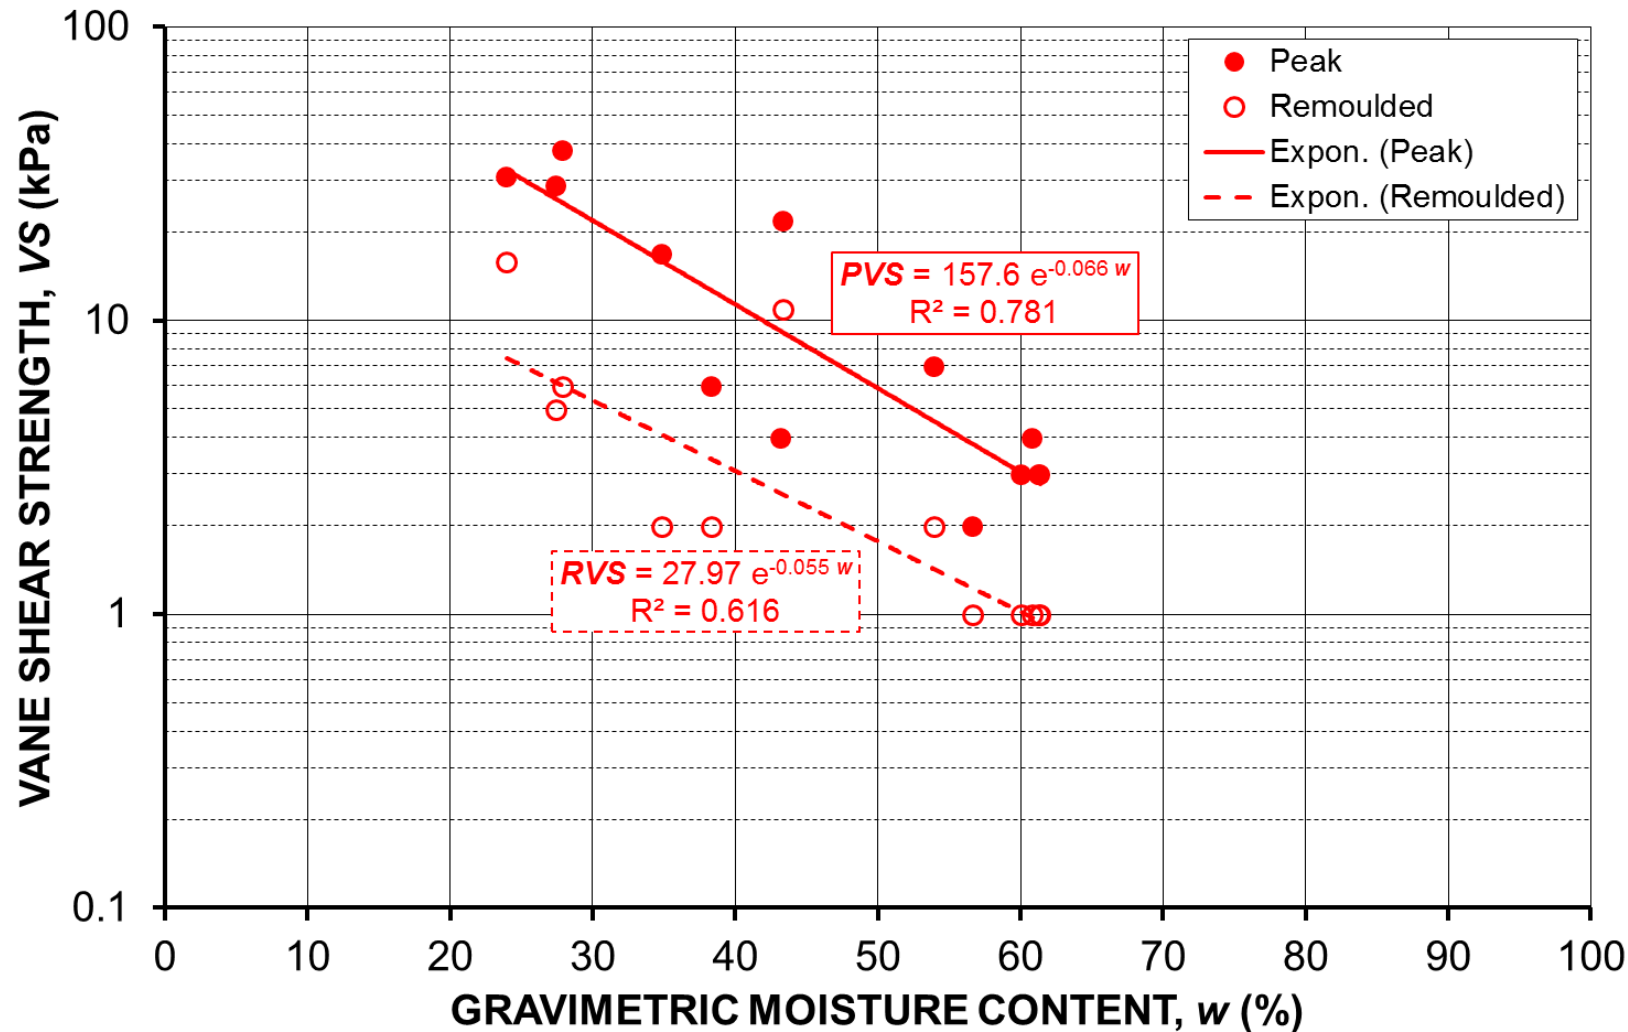
Vane Shear Strength vs Gravimetric Moisture Content

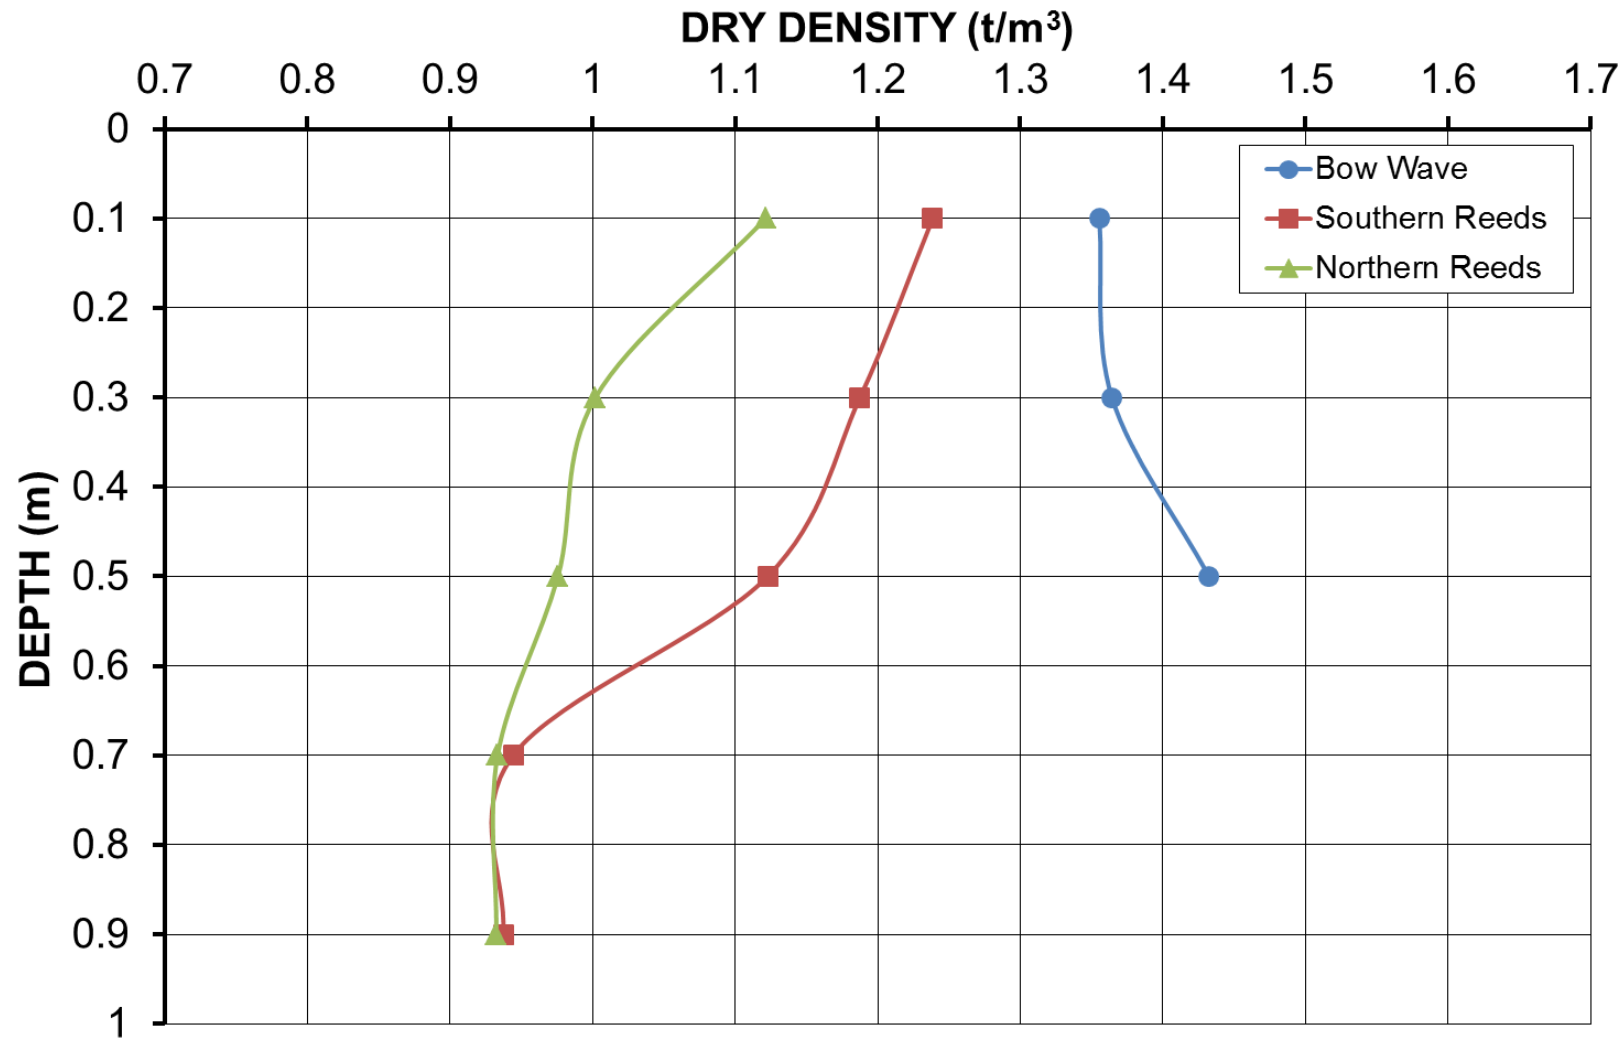
(Saturated) Dry Density versus Depth
