Tailings Closure: Planning, Implementation and Lessons Learned

Prof David Williams

Tailings Dams Rehabilitation and Closure at San Manuel, Arizona, USA

Capping Surface and In-Pit Tailings at New Acland Coal Mine, South-East Queensland

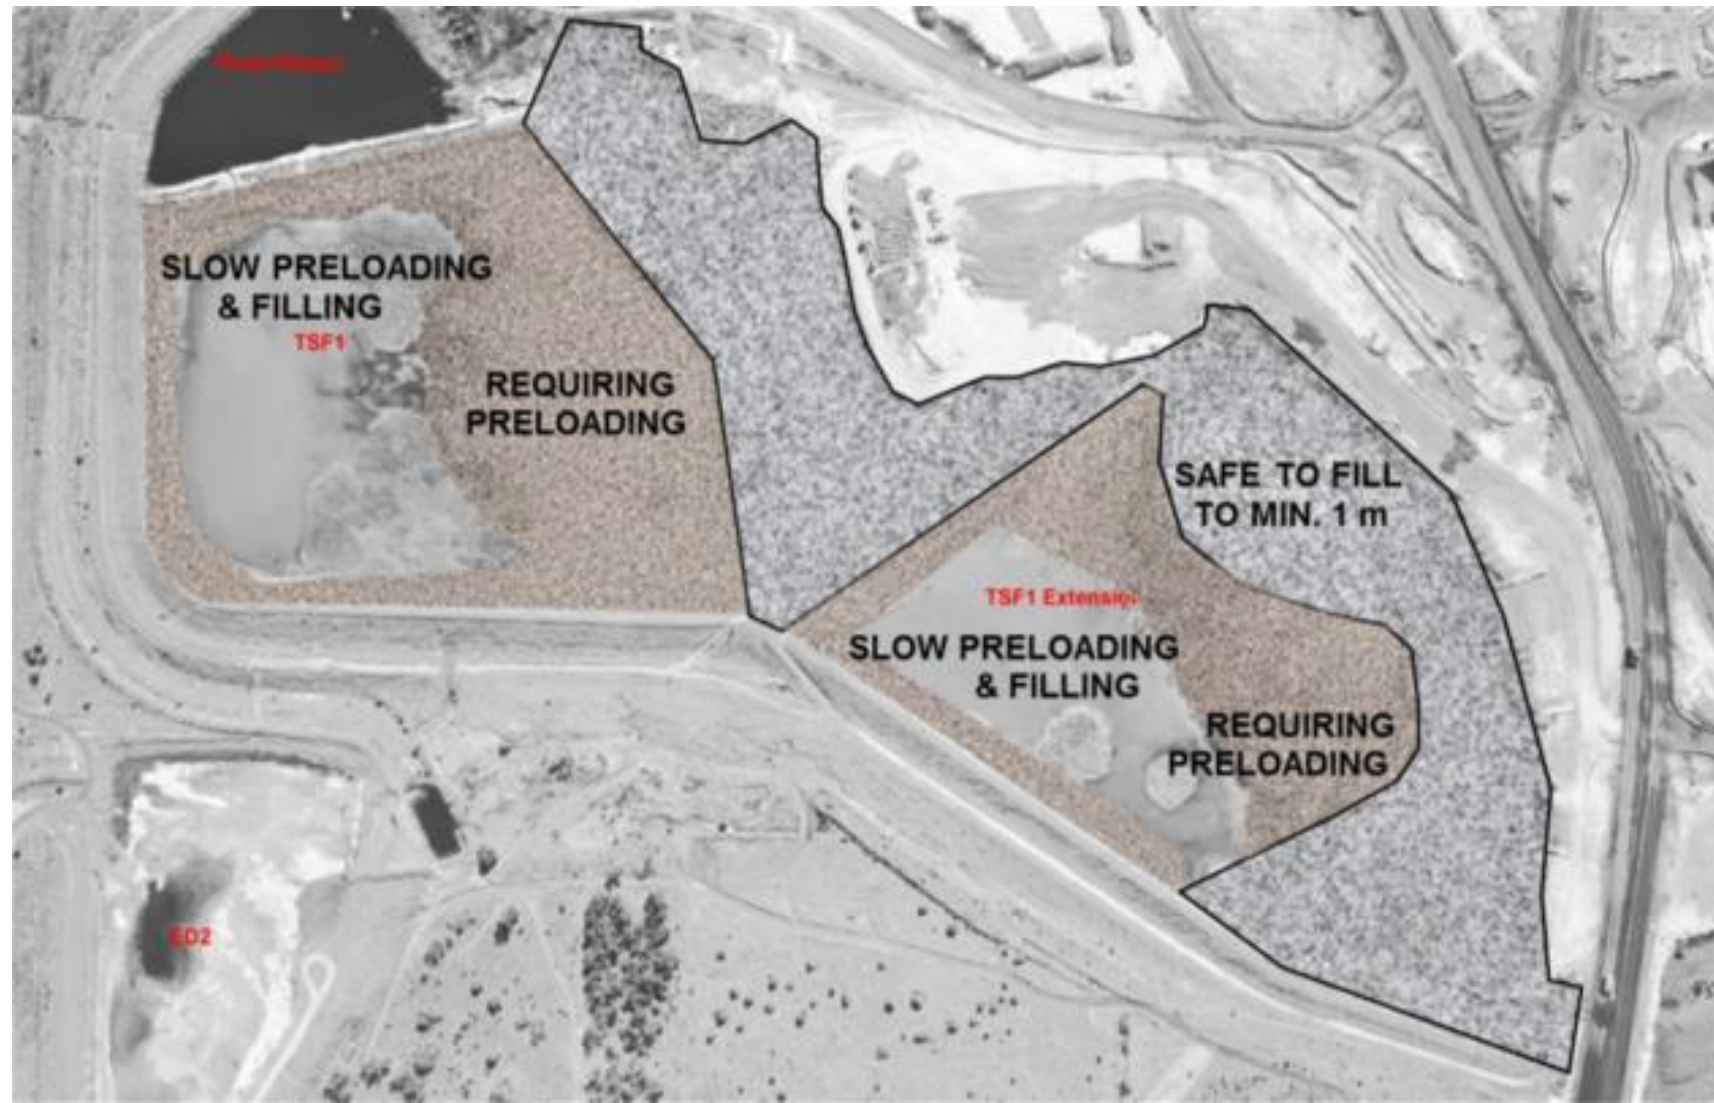
Identified Capping Zones

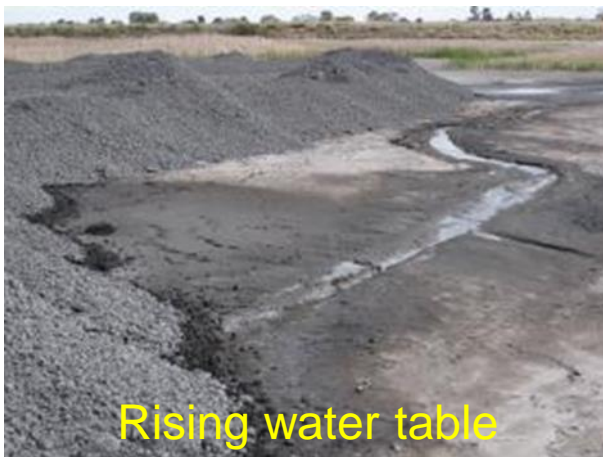
Pushing initial 1 m coarse reject capping by D6 Swamp Dozer over old bow wave

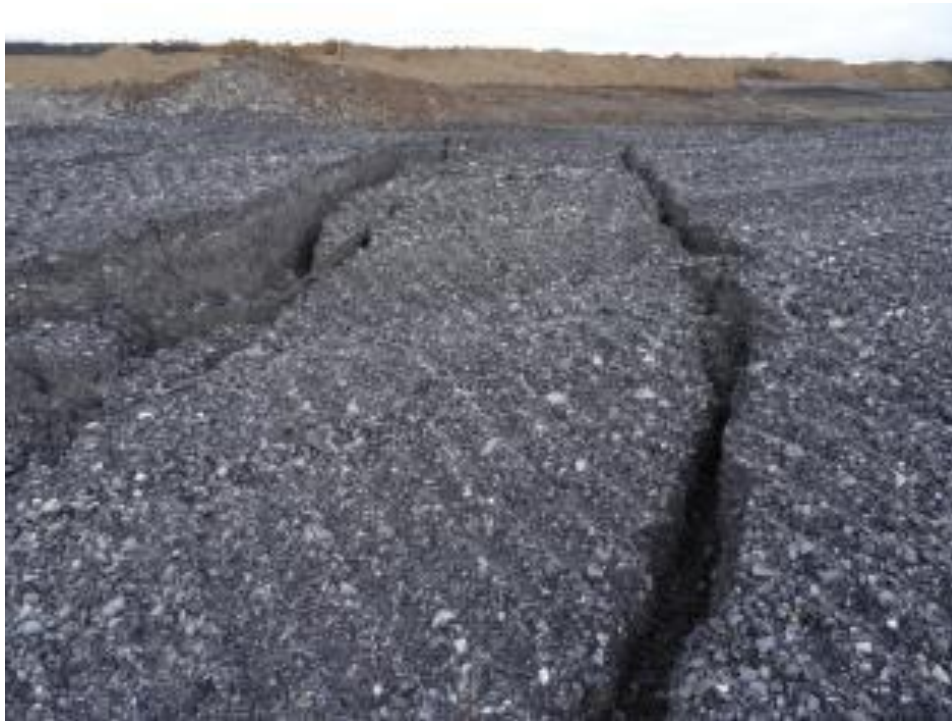
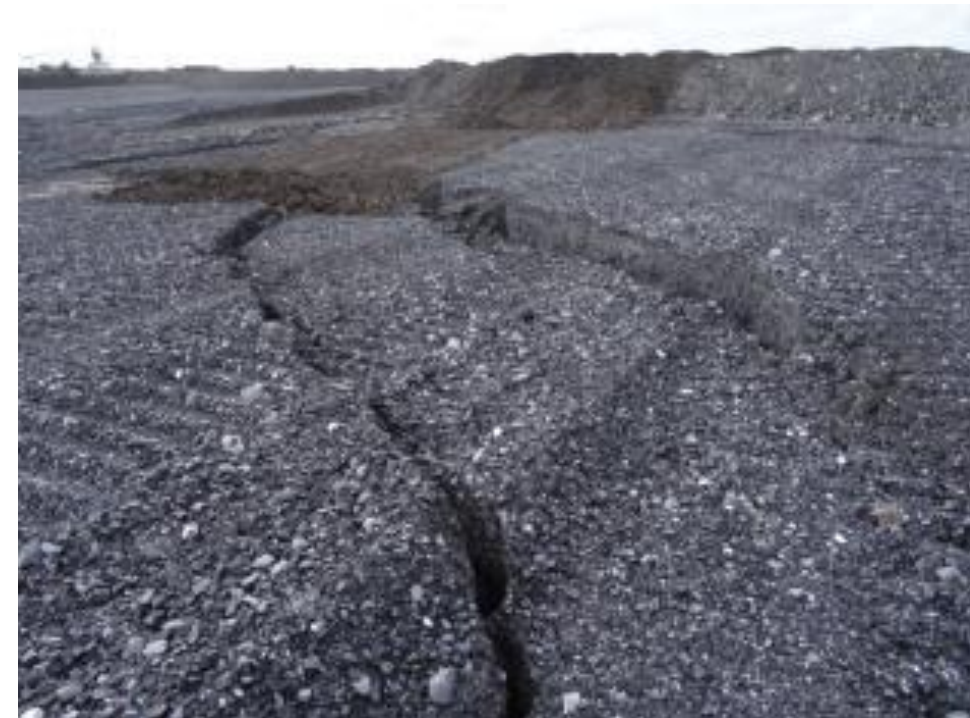
Up to 0.5 m High Scarps in Initial Capping over Soft Tailings

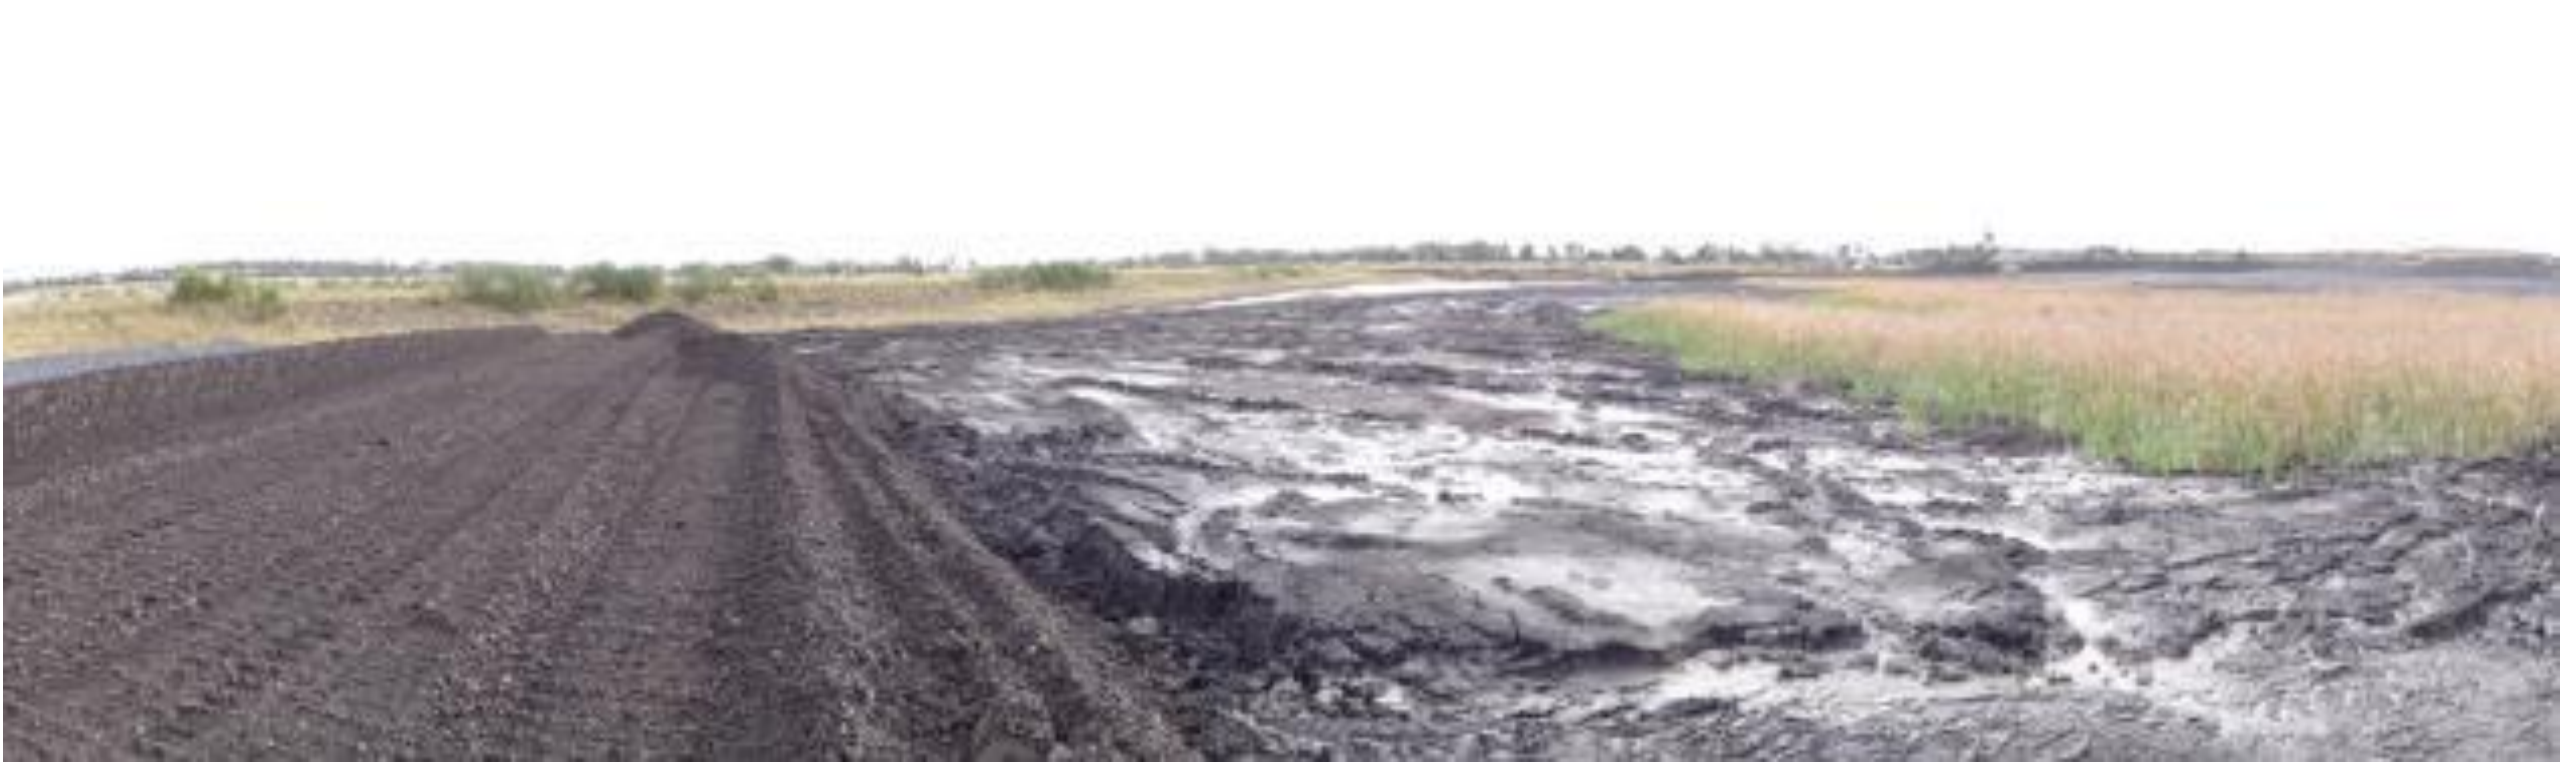
Significant Bow-Waving of Soft Tailings

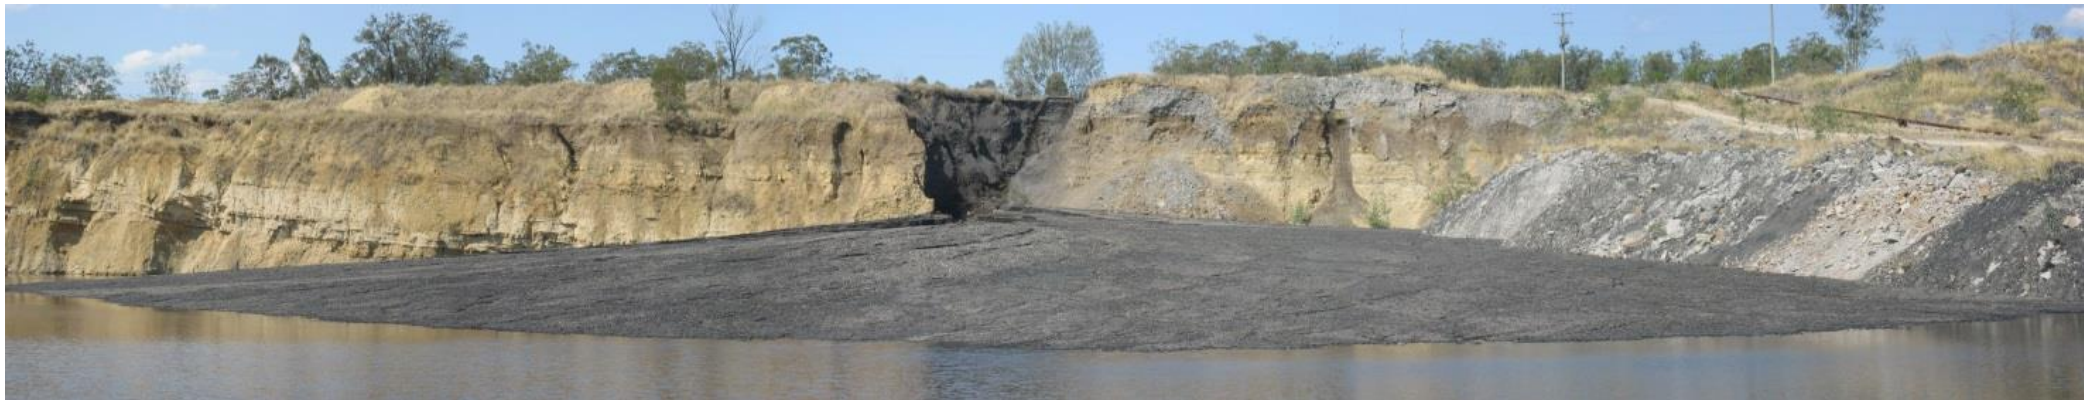
Hydraulic Placement vs End-Dumping of Coarse Reject

Hydraulic placement

- Dewater, and cap by dozing coarse reject from elevated beach:
Soft, wet tailings will be difficult to traffic
- Place coarse reject cap hydraulically:
Requires infrastructure
- End-dump coarse reject (waste) into wet tailings/water, displacing water and tailings to form a well-mixed layer, consolidating tailings sufficiently to support a D6 Swamp Dozer and additional capping
